LESSONS LEARNED FROM FAILURES DUE TO HURRICANES KATRINA AND RITA

C. Vipulanandan, Ph.D., P.E., Chairman and Professor
Director of Center for Innovative Grouting Materials and Technology (CIGMAT)
 Department of Civil and Environmental Engineering, University of Houston, Houston,
 TX

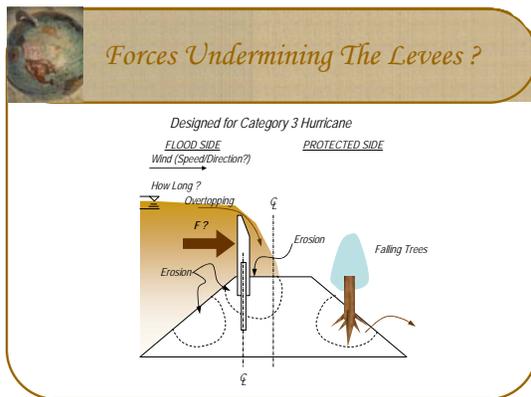
Figure 1. The Forces Undermining the Levee System

There are several on going studies on the performance of the New Orleans levee system during Hurricane Katrina and investigations for the reasons of failures by ASCE and NSF-sponsored levee assessment team(s) [1], USACE [2], and private investigators. The evidence suggest that a common mode of failure was the erosion of soils at the land side toes of floodwalls as water overtopped the concrete floodwalls atop the earthen levees where eroded levees reduced the lateral soil support

at the protected side of the walls, and reduced the walls’ ability to withstand the lateral forces produced by high waters on the flood side (Fig. 1). This was not a problem with T-walls as the concrete base of the inverted T-wall sections acted to deflect the overtopping waters and prevented erosion. T-walls also were constructed with more substantial supporting foundations.

It was learned that T walls should be the preferred floodwall types due to their successful performance during the hurricane and transitions between earthen levees, sheet piles, and concrete wall sections should be robustly designed so that such transitions do not represent locations of potential weakness. Also, improvement of the levee system could be implemented with the addition of overtopping erosion protection at the protected sides of the floodwalls through the placement of rip-raps, concrete splash slabs, or paving of the ground surface effective in reducing erosion.

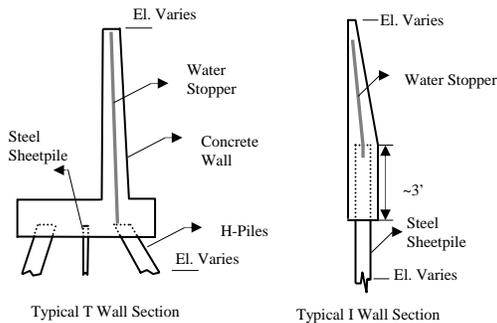
Figure 2. Typical Cross Sections of I-Wall And T-Wall

In a levee system where many elements came together, the weakest portion controlled the overall performance of flood protection system. The reported failures in the levee systems occurred mainly at earthen levees and I-wall sections where a concrete capped sheet pile (Fig. 2) was used both as a structural element and seepage cutoff purpose. Also, considerable erosional distress, and a number of failures, was noted at transitions between different earthen levee and concrete structural segments.
