ALMEDA TUNNEL – PAST, PRESENT AND FUTURE

Ravi Kaleyatodi, P.E., CPM
Senior Assistant Director, City of Houston
Ravi.kaleyatodi@cityofhouston.net

Paul C. Wallick, P.E.,
Senior Project Manager
Patricia Frayre, P.E.,
Design Manager
PATE Engineers, Inc., Houston

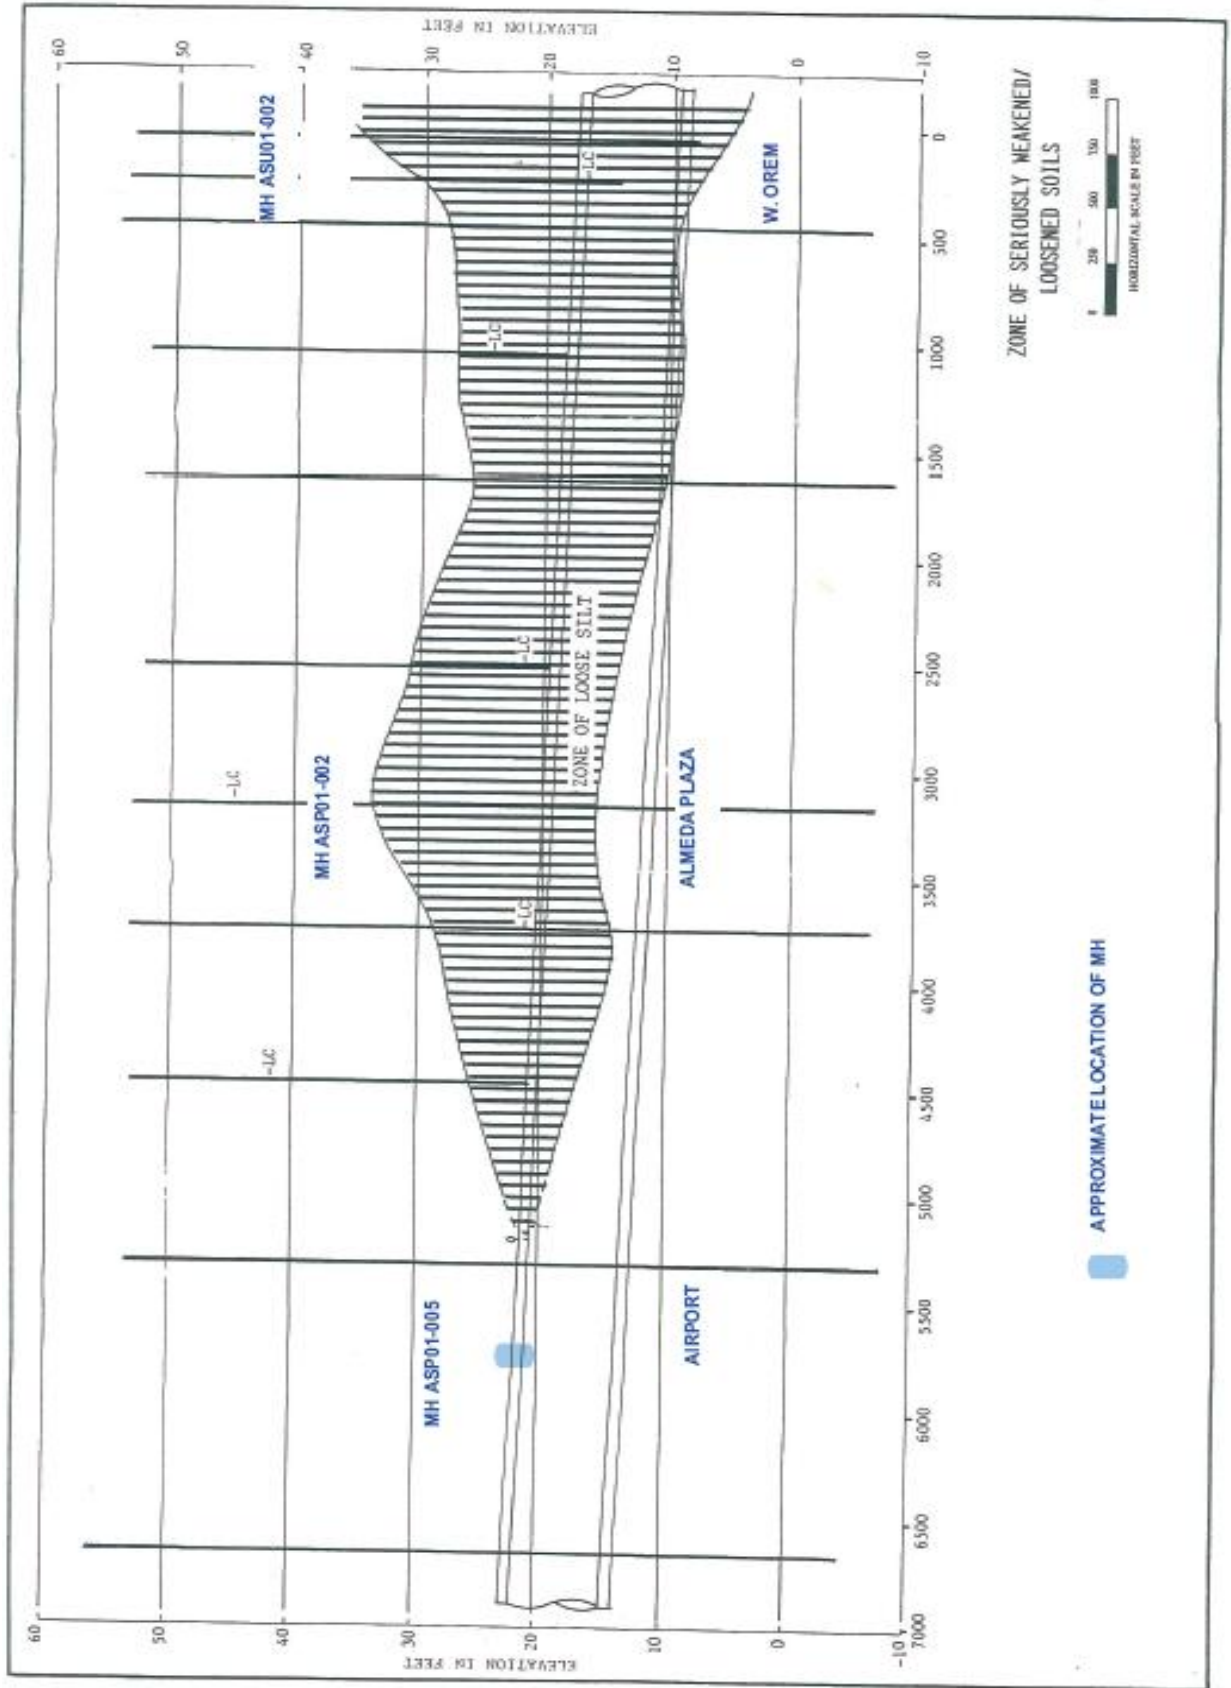
EXHIBIT 2

Extensive geotechnical investigation was conducted on all three occasions. A review of the subsurface soil conditions in the vicinity of the failure indicated that the sewer failure zone lies in very fine silty sands under hydraulic pressure. The top 20-feet of soil are composed of clay, and the next 25-feet are composed of sandy silts. At the depth where the sewer is located, the soil profile varies along the length from stiff clay in the downstream reach of the profile to fine sandy silts in the area of the failures and upstream. The exhibit on page 3 includes the profile of the 84-inch sewer and the zone of loose silt.

The television tapes of the line showed transverse cracks spaced in some case as close as every 4 to 5 feet, but more generally every 12 to 15 feet. Inflow exists at almost all of these cracks to varying degrees. The cracks appear to coincide with the spacing of steel ring beams in the ring beam and lagging tunneling technique. The concrete thickness is slightly reduced at the ring beam and thus slightly weaker. No filter material was employed either around the primary tunnel exterior or around the inner monolithic pipe to cut off material from being carried into the line at these points of inflow.

Small cracks in the concrete sewer allowed the very fine soil particles to leak into the sewer. The loss of these fine particles weakened the soil supporting the pipe and the pipe had to act as a bridge over the weakened section. Since the sewer pipe was not designed to act as a beam, additional cracks were formed. The cracks accelerated the loss of soil and soil strength. The continuing loss of soil strength accelerated the development of new cracks and enlargement of existing cracks.

When the extent of weakened soils exceeded the bridging capacity of the upper clay layer, a large plug of the clay failed and collapsed onto the interceptor. The sewer structure failed catastrophically, and a cave-in appeared at the surface above.

On all three occasions, the failure was due to a gradual removal of the fine grained silty soils through transverse cracks in the 84-inch sewer line which ultimately resulted in the surface collapse and sink hole. Faulting is not believed to be a contributing factor in the failure. This southern 5,600 LF of the tunnel alignment is embedded in the fine grained silty soil and experienced failure.
