EFFECTS OF TREES ON THE DEPTH OF THE ACTIVE ZONE

Kenneth E. Tand, P.E.
Kenneth E. Tand & Associates
2817 Aldine Bender Road
Houston, TX 77032
Phone: 281-590-171; Fax: 281-590-1430; E-mail: ktand@ketand.com

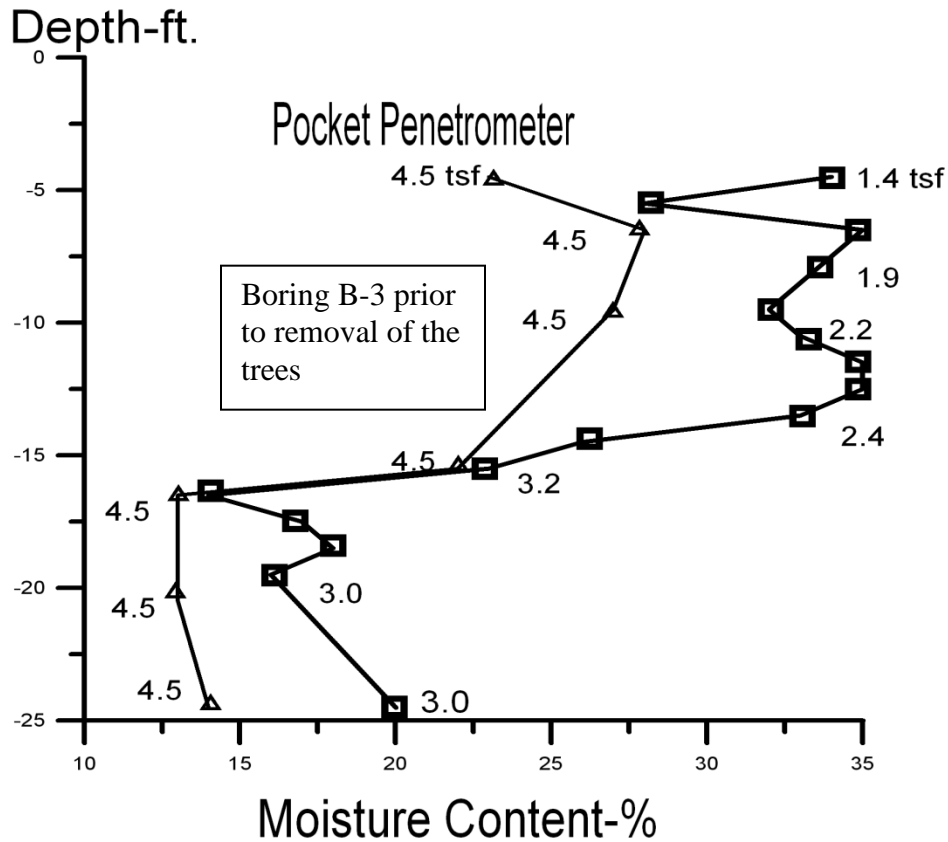
Figure 1: Variation of Moisture Content and Preconsolidation Pressure with Depth for CASE 1

The pre-construction potential vertical rise (PVR) computed using Tex 124-E was reported as ± 1 inch with the floor slab on $3\frac{1}{2}$ feet of select fill. Foundation movements were first noted about 3 years after completion of the buildings. Elevation surveys indicate that the east building's ground floor slab heaved ± 3 inches, and that the west building's ground floor slab heaved ± 5 inches. Elevations of the floor slab near the columns on the 2nd floor suggest that swell of the clays below the underreamed piers heaved them up $\pm 1\frac{1}{2}$ inches. Other possible explanations include: (1) tension failure occurred at the shaft/grade beam interface allowing the columns that are supported on the grade beams to move up independent of the piers, (2) the shafts were pulled apart due to tension, or (3) pullout of the piers occurred due to soil failure above the underreams.

Subsoil data from a nearby site without trees indicates that the depth of the water table was ± 15 feet in the early 1970s. Moisture demand of the trees at this site had caused the groundwater level to be lowered below 25 feet. Post-construction borings indicate that the water level rebounded to a depth of 17 feet within a period of about 6 years. This resulted in a bottom to top wetting front. In addition, there is an upper water table at a depth of about 4 feet suggesting that there was moisture migration from landscape areas around the buildings to under the slabs through sand backfill around sewer pipes, voids under the grade beams, and possibly leaking underground sewers.

The pre-construction depth of the active zone was estimated to be 7 feet. Shown on Figure 1 is a graph of moisture content/depth comparing the pre-construction versus post-construction laboratory data that indicates the depth of moisture change was greater than 25 feet. An average Tex 124-E moisture condition was assumed for start of swell. However, post-construction analysis suggests that the moisture condition was dry at the start of earthwork construction. The measured heave was 3 to 5 times greater than the initially reported PVR of ± 1 inch because the effects of the trees had not been understood.

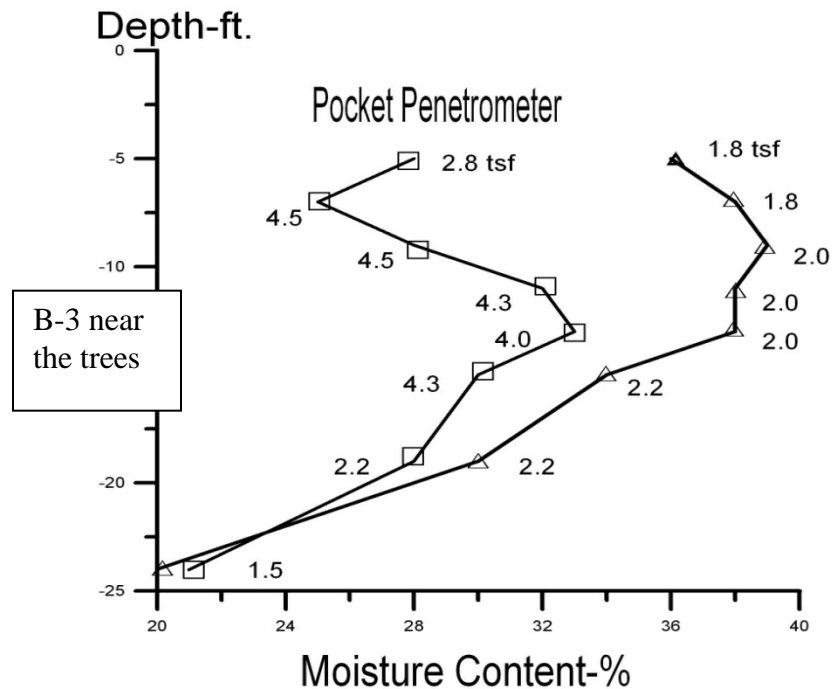
Figure 2: Variation of Moisture Content and Preconsolidation Pressure with Depth for CASE 2

The elevation survey indicated that $\pm 3\frac{1}{4}$ inches of settlement of the floor slab occurred at the SE corner. There was a $5\frac{1}{2}$ inch void under the slab indicating that the ground surface below the slab had settled $\pm 8\frac{1}{2}$ inches. About 1 inch of settlement occurred in the NE corner, and there was a $3\frac{3}{4}$ inch void under the floor slab. This indicates that the ground surface below the slab settled ± 5 inches.

Elevation of the floor slab on the 2nd level at the SE corner suggests that the underreamed pier settled ± 3 inches. This underreamed pier was probed and found to be bearing at a depth of 14½ feet below top of slab. The underreamed pier at the NE corner settled $\pm 1\frac{1}{4}$ inches. This pier was also probed and found to be bearing at a depth of 16½ feet below top of slab.

Two 20 to 32 inch diameter oak trees were located near the SE corner, and the drip line was within 6 feet of the perimeter. Abundant feeder roots were found in the upper 10 feet, with occasional feeder roots found between 10 and 15 feet. One 1/32 inch diameter live root was found at a depth of 19 feet. One large ash tree and a small oak tree were located near the NE corner. The drip line of the ash tree was at the perimeter of the building.

Shown on Figure 2 is a graph of moisture content/depth comparing the moisture content variation with depth at a boring near the SE corner of the building close to the trees, and at a boring well beyond the trees. The subsoil data indicates that the depth of moisture variation was about 20 feet below grade. The layer of water bearing silty clay at 22 feet was permeable enough to replenish moisture at the 20 foot depth as water was being sucked out due to moisture demand of the trees.
