## **PIPE BREAK ANALYSIS – WATER**

Aldo Ranzani,

Public Works and Engineering Department City of Austin, Austin, Texas

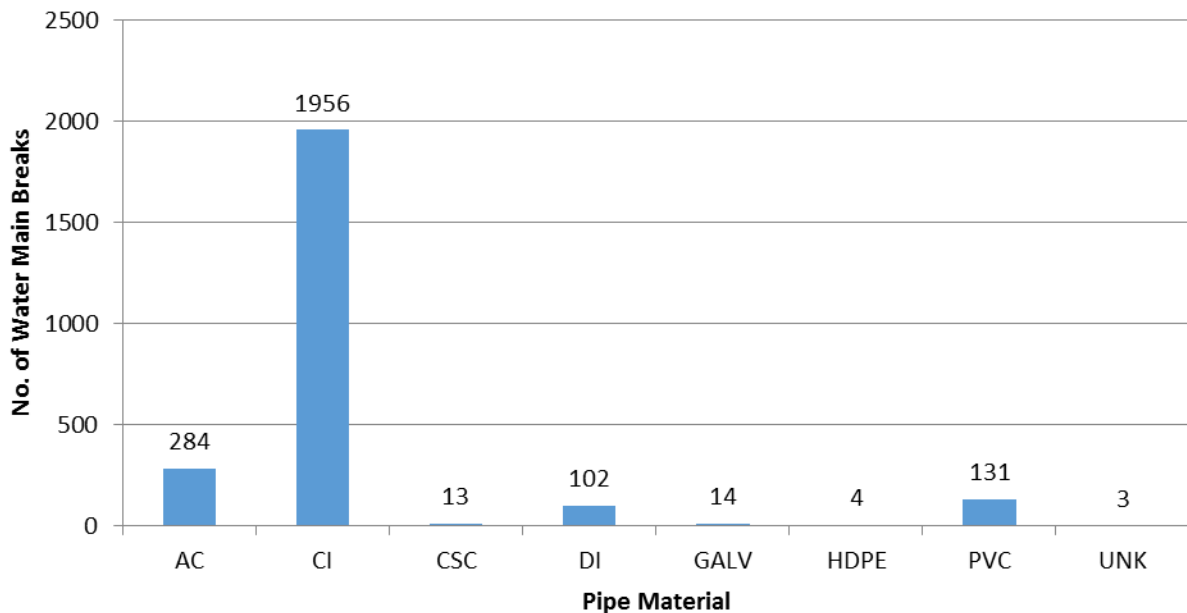
## Water Main Breaks By Material FY11 to FY15

A look at the pipe material most often involved with the repeated pipe breaks reveals cast iron (CI) to be a material of considerable interest. Nearly 78% of the pipe breaks occurred in cast iron pipe while only 30.40 % of the entire water system is cast iron. Approximately 99% of the cast iron pipe where the breaks occurred was installed prior to 1980. Most of it was installed before 1971, when Austin Water began to bed the trenches rather than bury the pipe directly in the ground. Consequently, most of the CI pipe where the breaks occurred is at least 30 years old and is buried directly in the ground – unprotected from soil elements and ground movement.

Approximately 11.34 % of the AC pipes in the water system suffered breaks during the FY11-FY15. PVC pipe was involved with 5.23% and DI pipe with 4.07% of the pipe breaks studied.

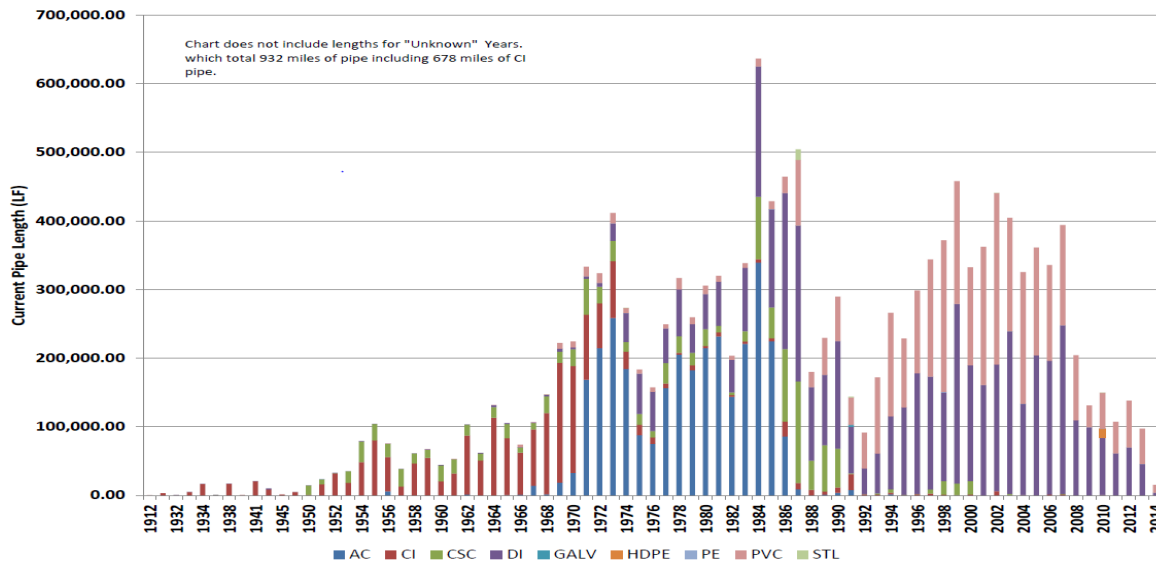
**Figure 1 - Pipe Material and Length by Year Installed**

Approximately 90% of the pipe where breaks occurred is 30 years old or older. In fact, 41.5% of the entire water system is at least 30 years old, and another 14.9% was installed in the 1970's, making it very nearly 30 years old itself. All told, 56.4% of the system is aging and may eventually need maintenance or replacement.

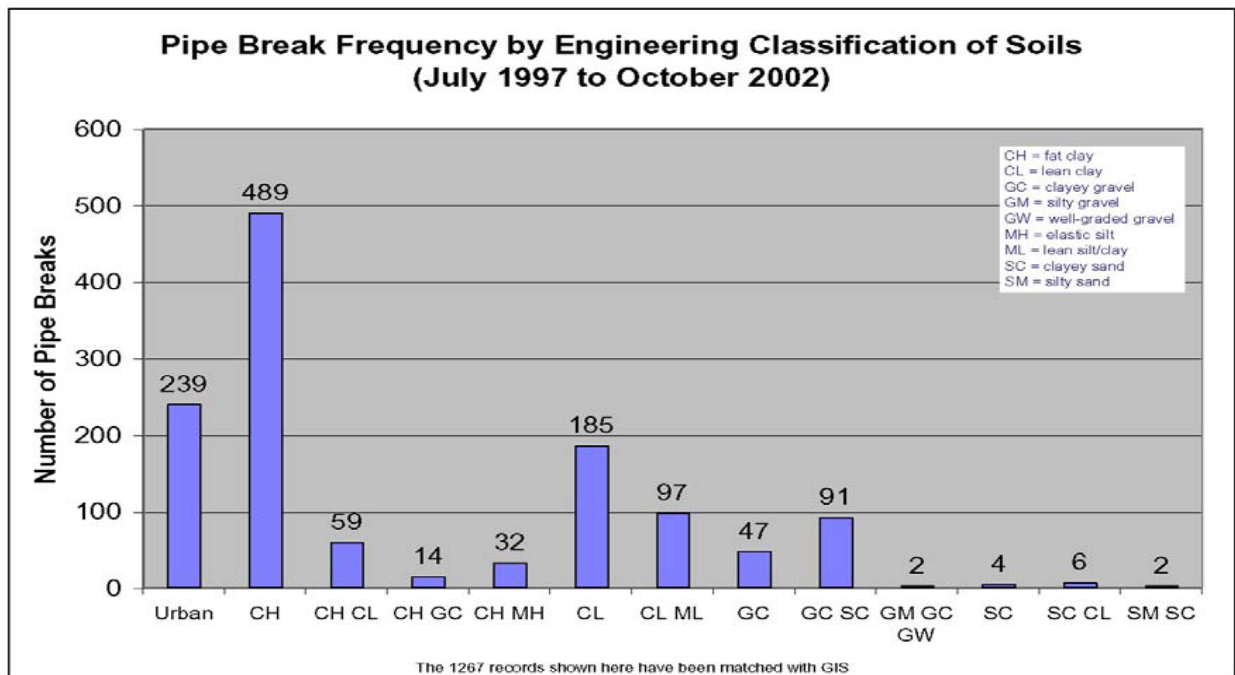
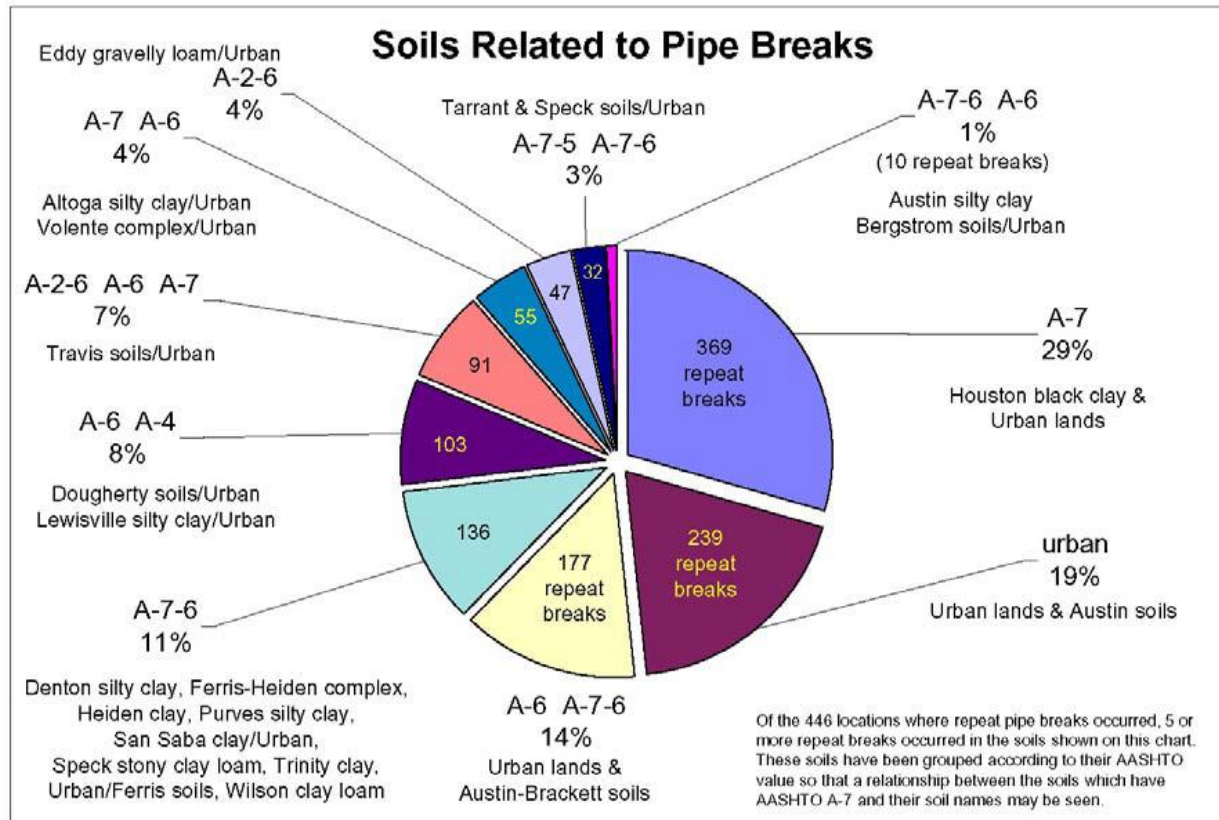
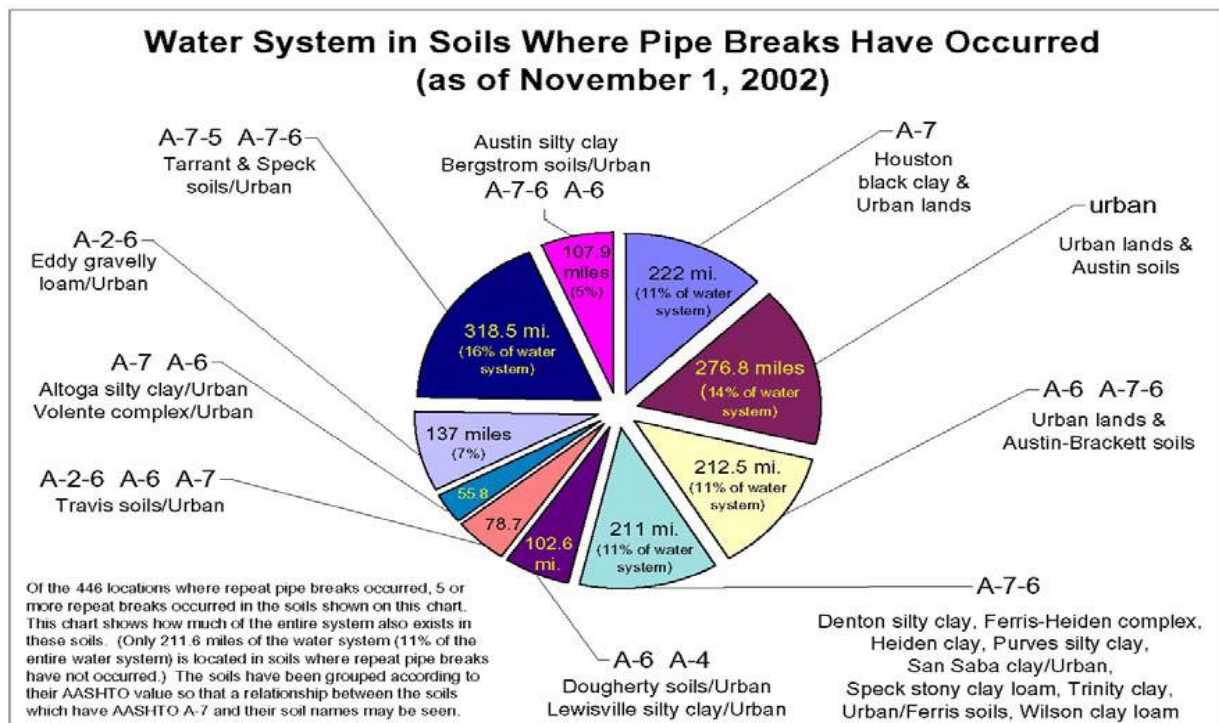
The greatest number of repeat pipe breaks occurred in clays (primarily fat clays) and urban areas. The Austin area soils are largely clay, many of them fat clays, so this is not a surprise. However, Houston black clay figures prominently in the numbers of the repeat pipe breaks. Per 2002 study, from July 1997 to October 2002, 1267 repeat pipe breaks happened with 29% of the repeat pipe breaks in Houston black clay and urban areas on Houston black clay (fig. 14), even though only 11% of the water system is laid in Houston black clay. So 369 of the 1267 repeat pipe breaks happened in only 222 miles of the water system. However, it should be noted that 94% of these pipes were installed before 1978 and are aging. (Houston black clay is a fat clay with an AASHTO (American Association of State Highway and Transportation Officials) soil classification of A-7. Soil classifications of A-6, A-7, or a combination of these two are silty clayey soils.)

Only 11% of the water system is laid in these soils (roughly the same amount of the system which is laid in Houston black clay). Approximately 97% of the pipes in these soils were installed before 1974. From this comparison, while the pipe break numbers are still high for this soil, it becomes apparent that Houston black clay is somehow hard on our water system. (This soil has an AASHTO classification of A-6 A-7-6.)

In contrast to the high pipe break soils, only 3% of the pipe breaks occurred in Tarrant-Speck soils and Urban lands. Approximately 16% of the water system is laid in these soils. Approximately 87% of the pipes in these soils were installed before 1980.

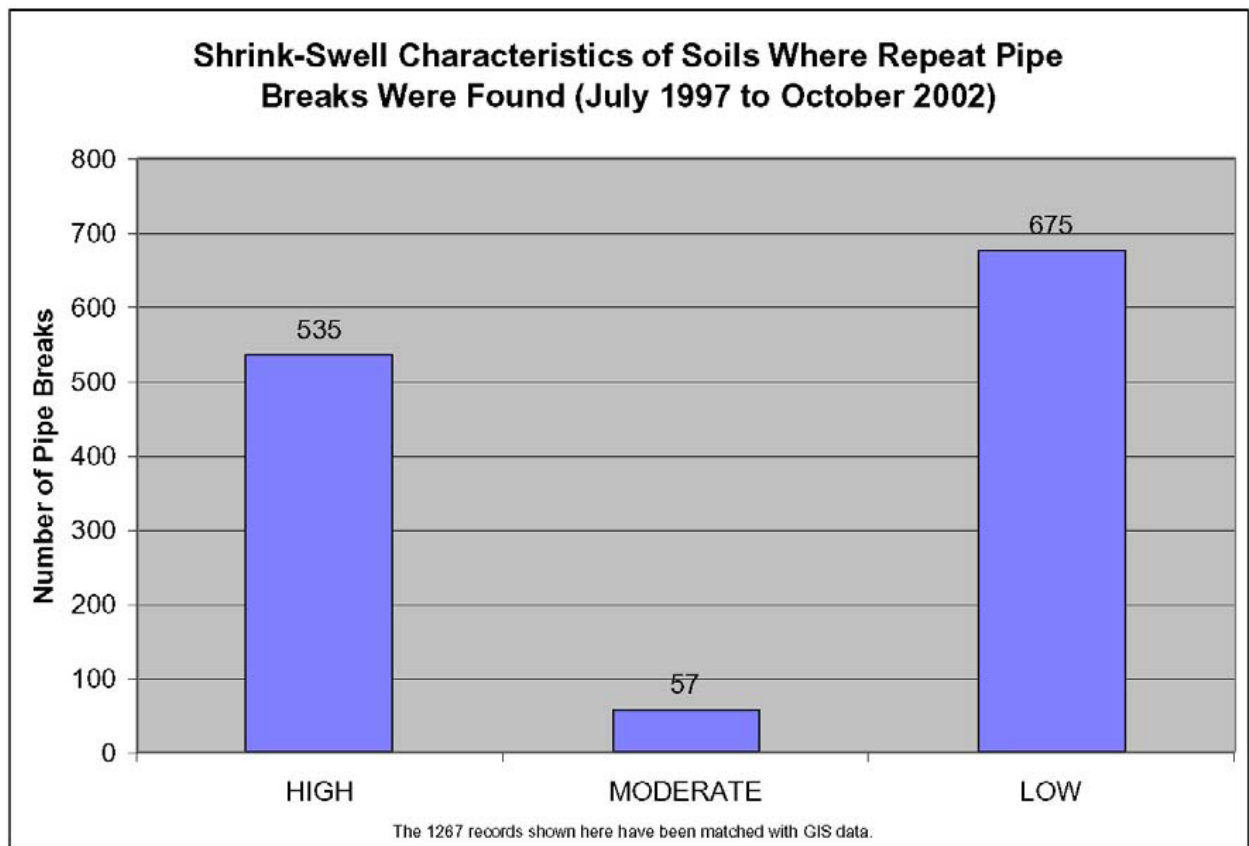
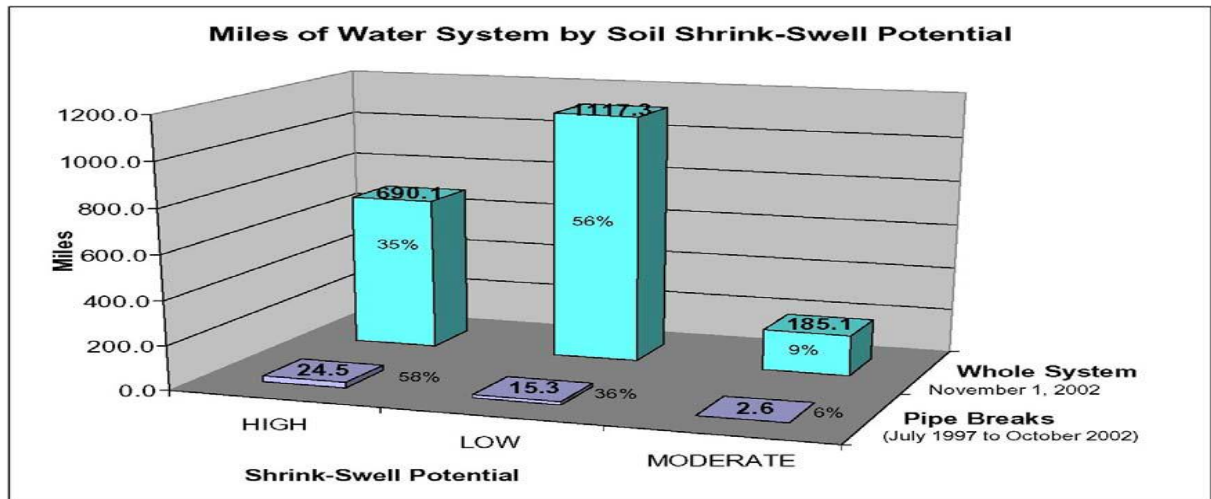
From July 1997 to October 2002 ,53% of the repeat pipe breaks occurred in soils which do not shrink and swell a lot at the depths where Austin water system would be typically buried. Approximately 42% occurred in soils that do shrink and swell. Only 35% of the system resides in high shrink-swell soils. About 56% reside in low shrink-swell soils. While, according to these numbers, soil shrink-swell potential is not a major contributor to the frequency of pipe breaks, it does appear to be a contributor upon occasion. Lateral fractures in the pipe have been seen in the field indicating that some form of linear stress is being applied to the pipe – quite possibly from soil movement.

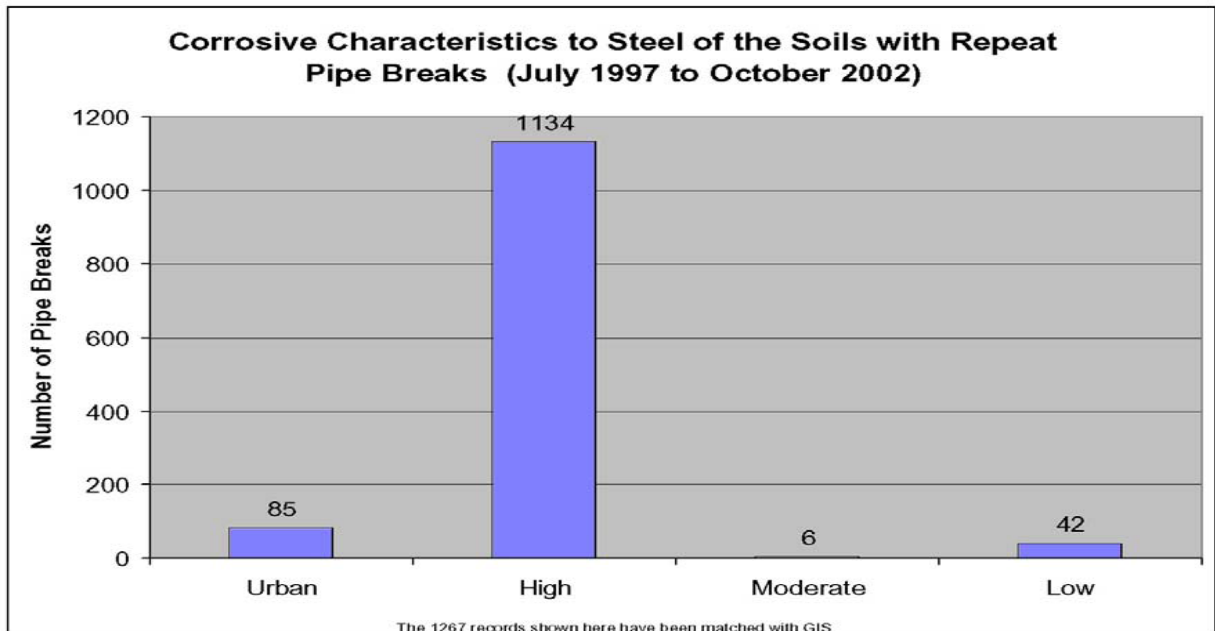
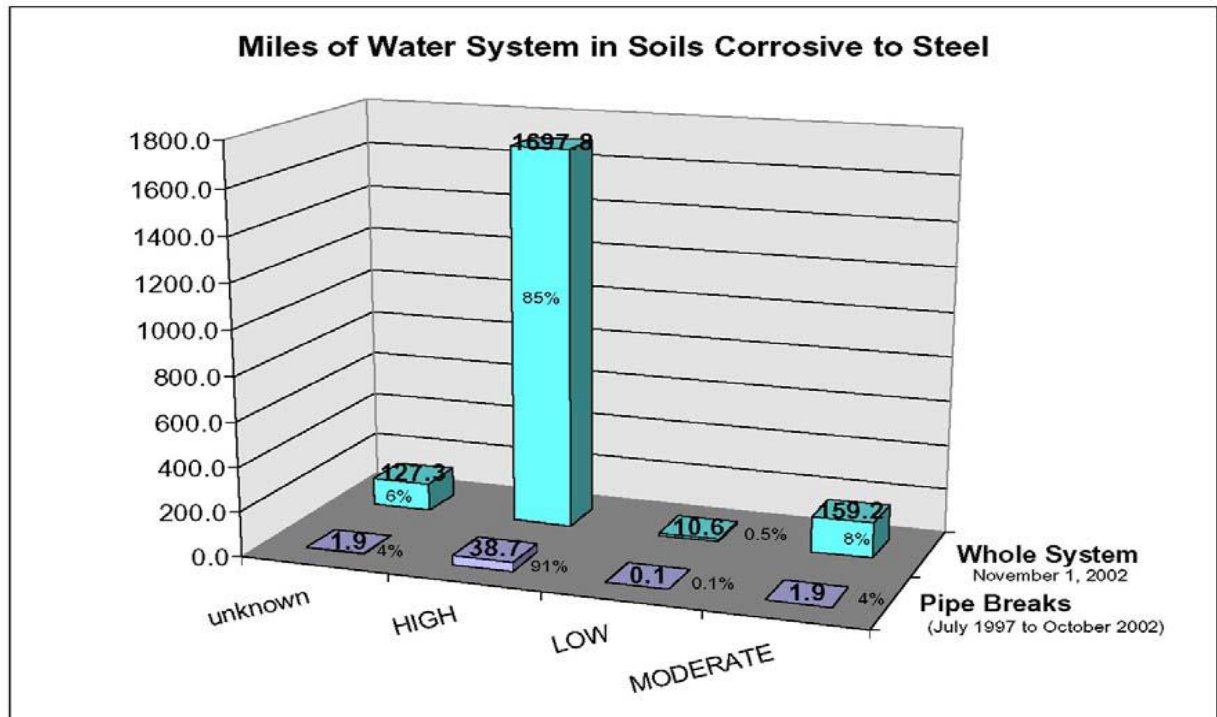
Approximately 89.5% of the repeat pipe breaks from 1997 to 2002 occurred in soils which were highly corrosive to steel (fig. 18). However, 85% of the water system resides in soils which are highly corrosive to steel, and 8% resides in soils which are moderately corrosive to steel (fig. 19). So, if a pipe were to break, it is very likely that it would reside in soil highly corrosive to steel. Corrosion is often seen on broken CI pipes, though, so soil corrosivity cannot be ignored as a contributor to the frequency of pipe breaks.

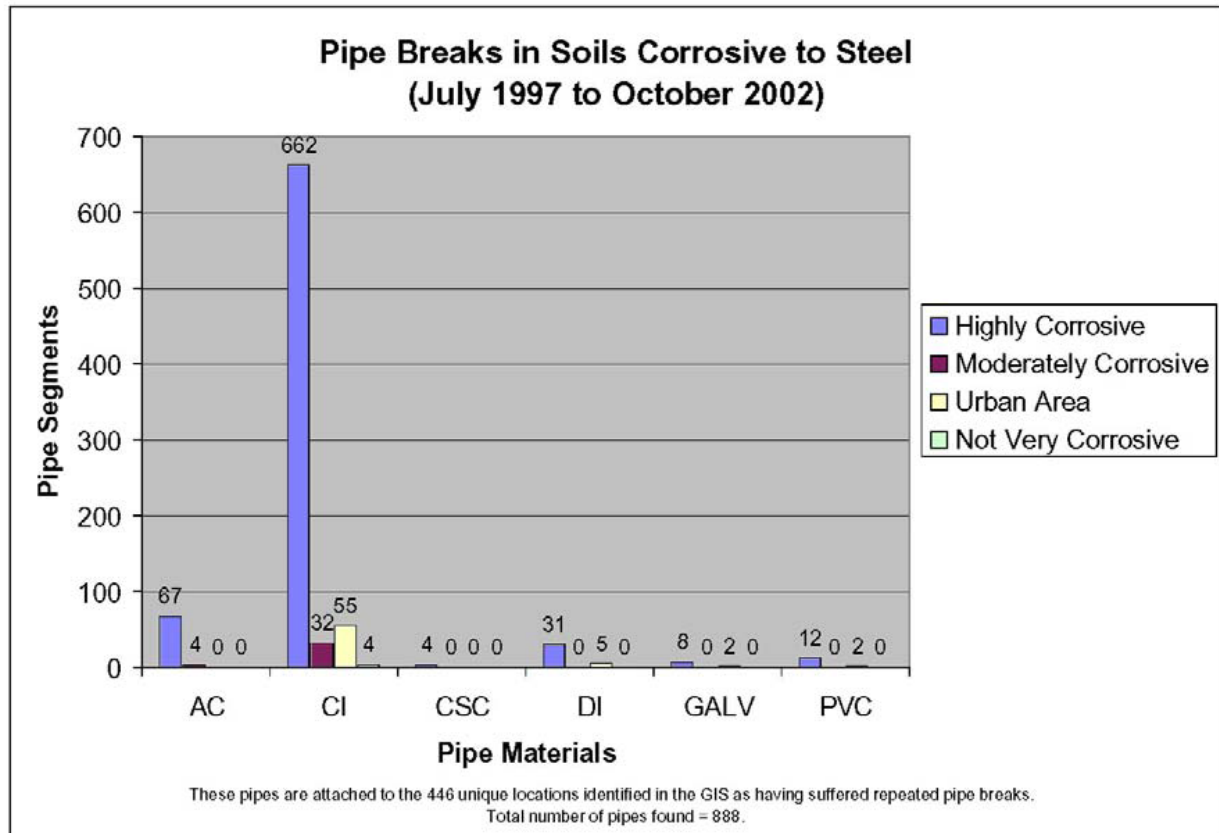
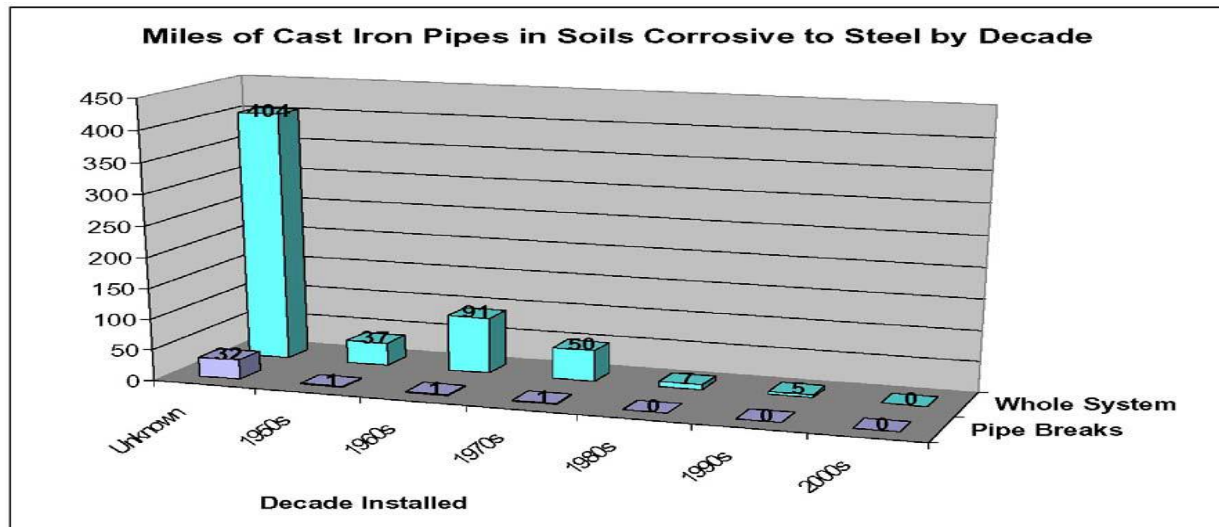
Since 85% of the pipes that broke were cast iron (CI) and 89.5% of the repeat pipe breaks occurred in soils corrosive to steel, the number of cast iron pipes which broke in corrosive soil becomes interesting. Approximately 75% of the cast iron pipes which broke during the study period were located in soils corrosive to steel (fig. 20). Approximately 34.3 of the 35 miles of cast iron pipe located in corrosive soils were installed prior to 1971. These pipes were typically laid directly in the soil (without bedding or protective wraps), and they are now over 30 years old. The 0.7 miles of pipe suffering breaks which did get laid with bedding in the trench to protect it from soil and soil movements, did not receive any protective wrapping. These pipes are nearly over 30 years old themselves

Over the entire system, 532 miles of cast iron (26.7% of the system) was laid directly in corrosive soils before 1970. Another 28 miles was laid in 1970 and 1971. Almost none of

these pipes were laid with any bedding or protective wrappings, and all of them have been in the ground for over 30 years. About 27 more miles of cast iron (installed between 1971 and 1987) were laid in bedded trenches, but without protective wrappings, bringing the total of generally unprotected cast iron pipe in the system to 587 miles (29.4% of the whole system).

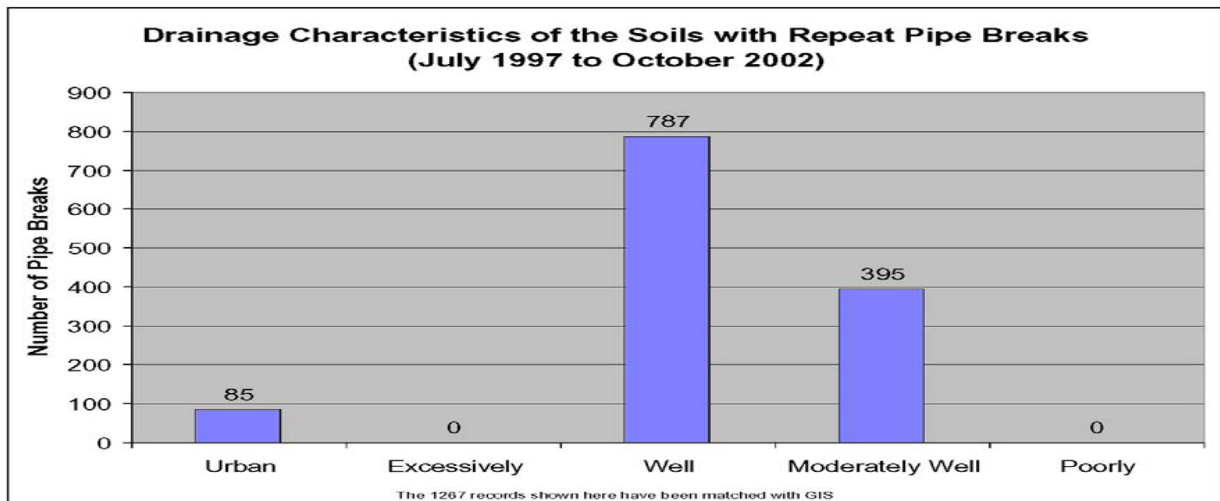
Most of the soils around Austin drain well or moderately well. Approximately 395 repeat pipe breaks (31%) occurred in soils that drained only moderately well. Approximately 787 of the breaks (62%) occurred in soils that drain well. While drainage can be a factor in soil movement, especially when dealing with fat clays, it would appear that it is a very minor factor with respect to the repeat pipe breaks in this study
