Effects of Vegetation on Foundations Bearing in Expansive Clays in Urban Environment

Kenneth E. Tand, P.E.

Practicing Geotechnical Engineer
Kenneth E. Tand & Associates
2817 Aldine Bender Rd,
Houston, Texas 77032

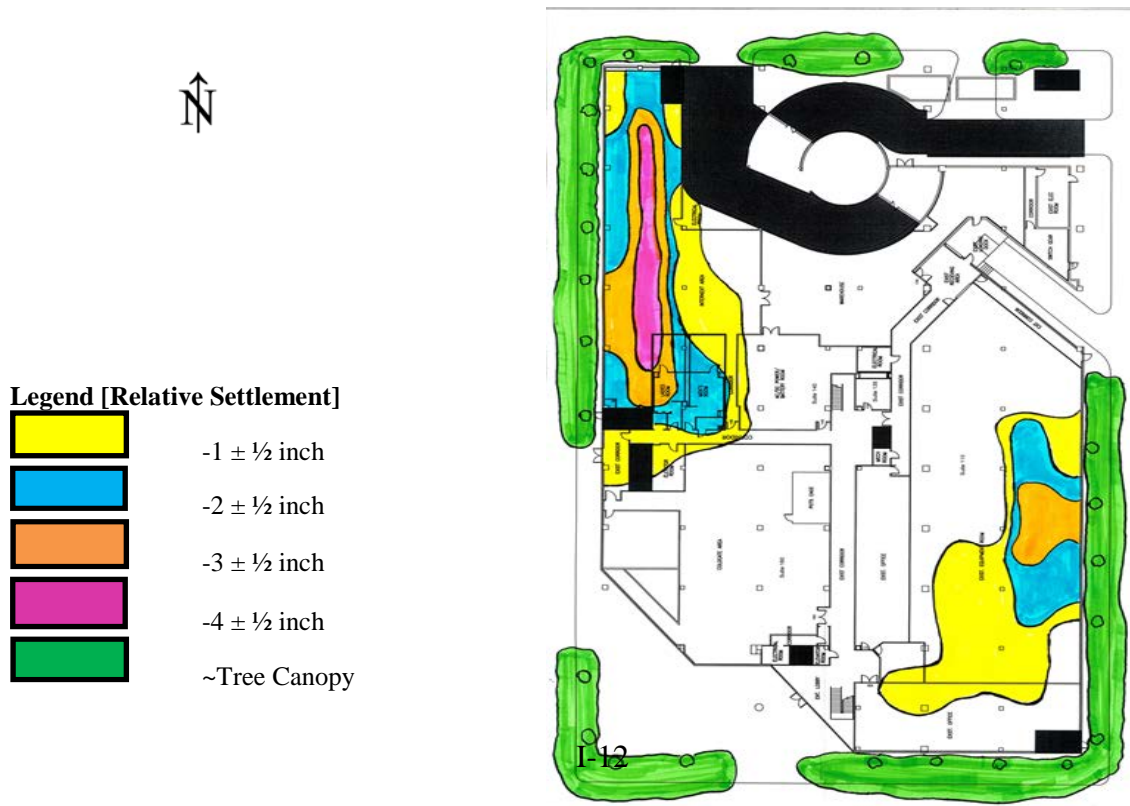
Figure 1
Contours of Elevation/Ground Floor

An elevation survey was performed in November 2013, and the contours of relative floor slab movements are shown on Fig. 1. The contours of slab movement are based on a benchmark located in the center of the building next to a column where the elevation survey shows that little floor movement had occurred. Construction tolerances are generally $\pm\frac{1}{2}$ inch when floor slabs are poured, but could be 1 inch or more if poor quality control occurs. Elevation measurements were made with a digital water level with an accuracy of 0.1 inch. I have also found 0.2 inches of elevation variations within a 3 foot square due to floor slab imperfections. There are also issues regarding total and differential settlement of the footings that occurred. Thus, the contour lines are not entirely accurate, but are certainly within the accuracy needed when performing forensic studies.

About $4 \pm \frac{1}{2}$ inches of settlement of the floor slab was found along the easterly half of the north wall, and $3 \pm \frac{1}{2}$ inches along the westerly half of the south wall. The elevation survey on the 2nd floor indicated that $3 \pm \frac{1}{2}$ inches of settlement occurred at one footings on the north , one on west, and one on south walls. The maximum differential settlement of the footings between adjacent exterior columns was $2\frac{1}{2} \pm \frac{1}{2}$ inches. Also, $2 \pm \frac{1}{2}$ inch of differential settlement occurred between interior columns and exterior columns.

More than 20 oak trees ranging from 14 to 24 inches in diameter were planted around the perimeter of the building. The canopies of the trees were located close to the exterior walls, and most had to be pruned to keep branches from rubbing against the exterior walls and window glass. I found that very little settlement occurred in areas not close to trees.

Remedial action included removal of all the trees in the fall of 2014, and installation of a horizontal moisture barrier to slow the rate of rehydration of the clays. An elevation survey performed in February 2017 indicates that the footings along the north and south

The lessons learned are not to plant trees close to buildings, and that it is very difficult to install a vertical or horizontal barrier that will slow rapid rehydration of the clays. A deep foundation system with a structurally suspended slab will be required if trees are to be planted next to buildings.

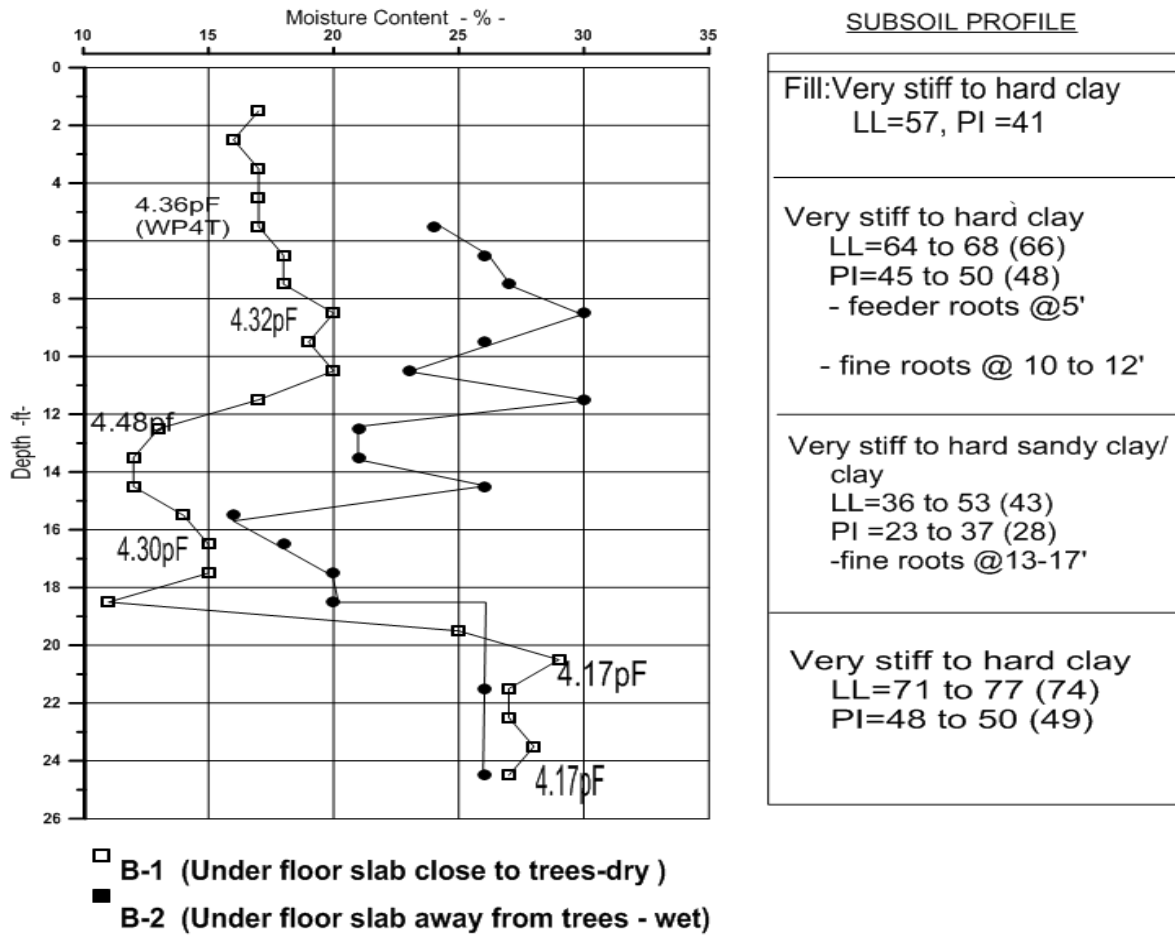
**Figure 2
Subsoil Moisture/Depth Profile
Case History 1**

Feeder and fine roots were found between the depths of 5 to 17 feet in boring B-1 under the floor slab. The boring was beyond the drip line of the tree which is commonly, not correctly, assumed to be the extent of the root system. Free water was not encountered when drilling boring B-1 close to trees, but was encountered at a depth of 19 feet below top of slab in an area away from trees. The preconstruction depth of the groundwater level was probably higher.

The survey data indicates that the elevation of the floor slab at boring B-1 was $\pm 3\frac{1}{2}$ inches below what existed at the time of initial construction. This implies that total settlement of the original ground surface below the floor slab was ± 6 inches when considering that a $2\frac{1}{2}$ inch void was found below the settled slab.

A comparison of the moisture content profile at boring B-1 near the trees, and at boring B-2 in the truck dock away from trees, suggests that the depth of moisture loss due to the trees is about 20 feet below top of the slab. However, I generally find soil suction values of 3.6pF to 3.8pF at similar depths when trees are not present. Thus, the high 4.2 pF soil suction below 20 feet suggests that the depth of moisture loss was probably deeper. The results of the swell test at 24 feet indicate that 0.4 percent volumetric swell of the clay sample occurred at this depth. No swell would have been measured if the clay sample had been saturated. This opinion is further substantiated by the high pocket penetrometer value of 4.2 tsf at 24 feet in boring B-1, compared to the 2.2 tsf value at B-2 away from the trees. High pocket penetrometer values are typically due to high soil suction. The geotechnical engineer must examine all the different tests when conducting engineering analysis in order to render credible opinions.

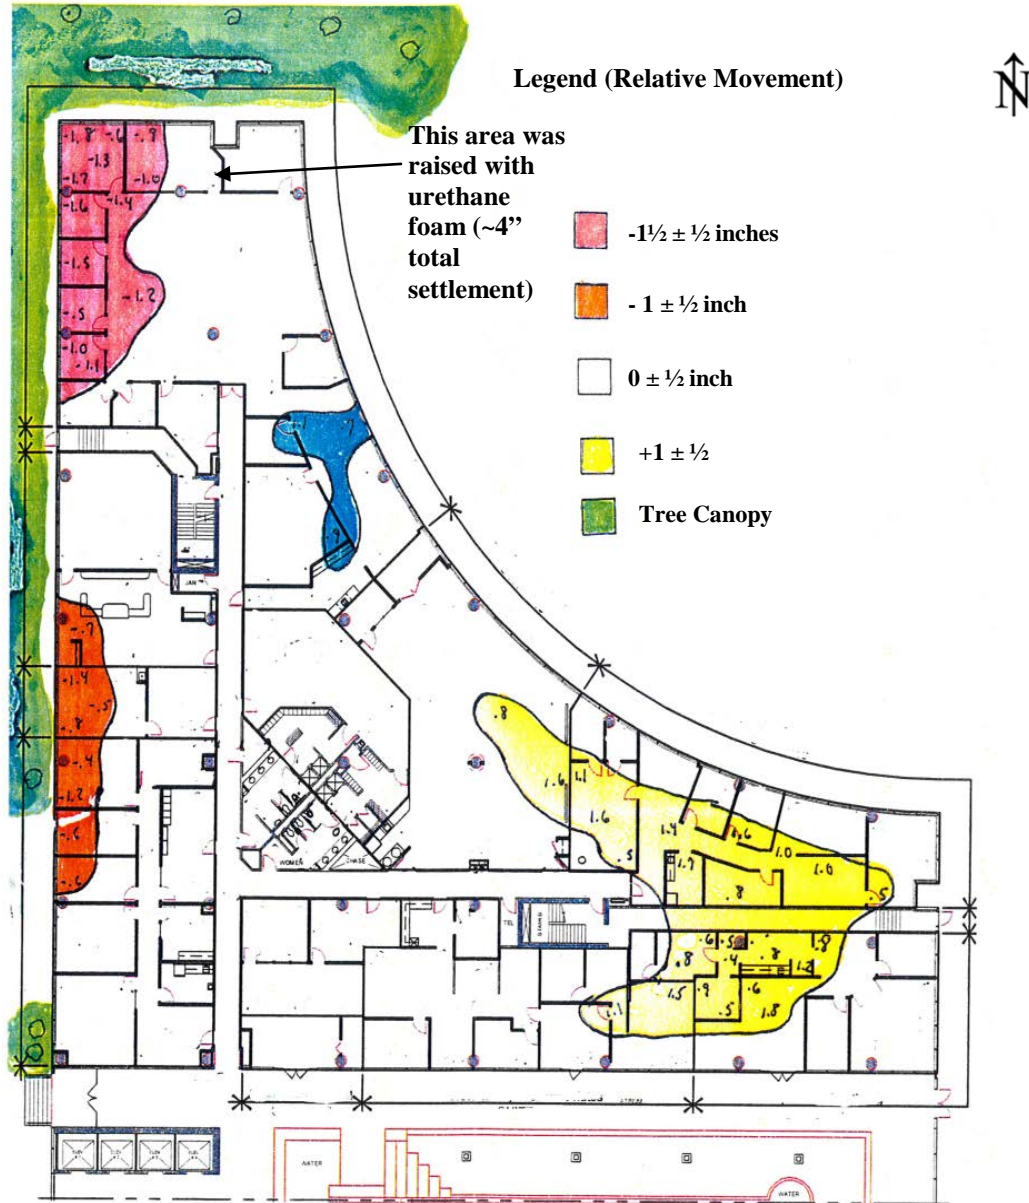
Fig. 3
Contours of Elevation Ground Floor

A cursory elevation survey had been performed by a contractor in January 2012 prior to injection of urethane foam to level the slab. The elevation survey after injection shows that the slab was raised 2 ± 1 inches. I performed an elevation survey in January 2014, and found that another $\pm 1\frac{1}{2}$ inches of additional settlement of the floor slab had occurred at the northwest corner of the building in a 2 year period. Also, ± 1 inch of settlement was found along the west wall south of this area. The contours of relative floor slab movements are shown on Fig. 3.

I often find that both heave and settlement have occurred in different locations in large commercial buildings. I found that $1 \pm \frac{1}{2}$ inches of heave had occurred in the southeast corner of the building.

the northwest corner. The canopies of the two trees nearest the building were close to the exterior walls, and they had to be pruned to keep branches from rubbing against the window glass. I found that very little settlement of footings occurred in areas not close to trees.

The cost to underpin the footings, and structurally suspend the floor slab was prohibitive, not to mention that it would be disruptive to the tenants leasing the ground level floor. Remedial action included installation of an 8 foot deep vertical moisture barrier to slow the rate of rehydration of the clays. Additional injections of urethane foam to level the floor slab were not performed.

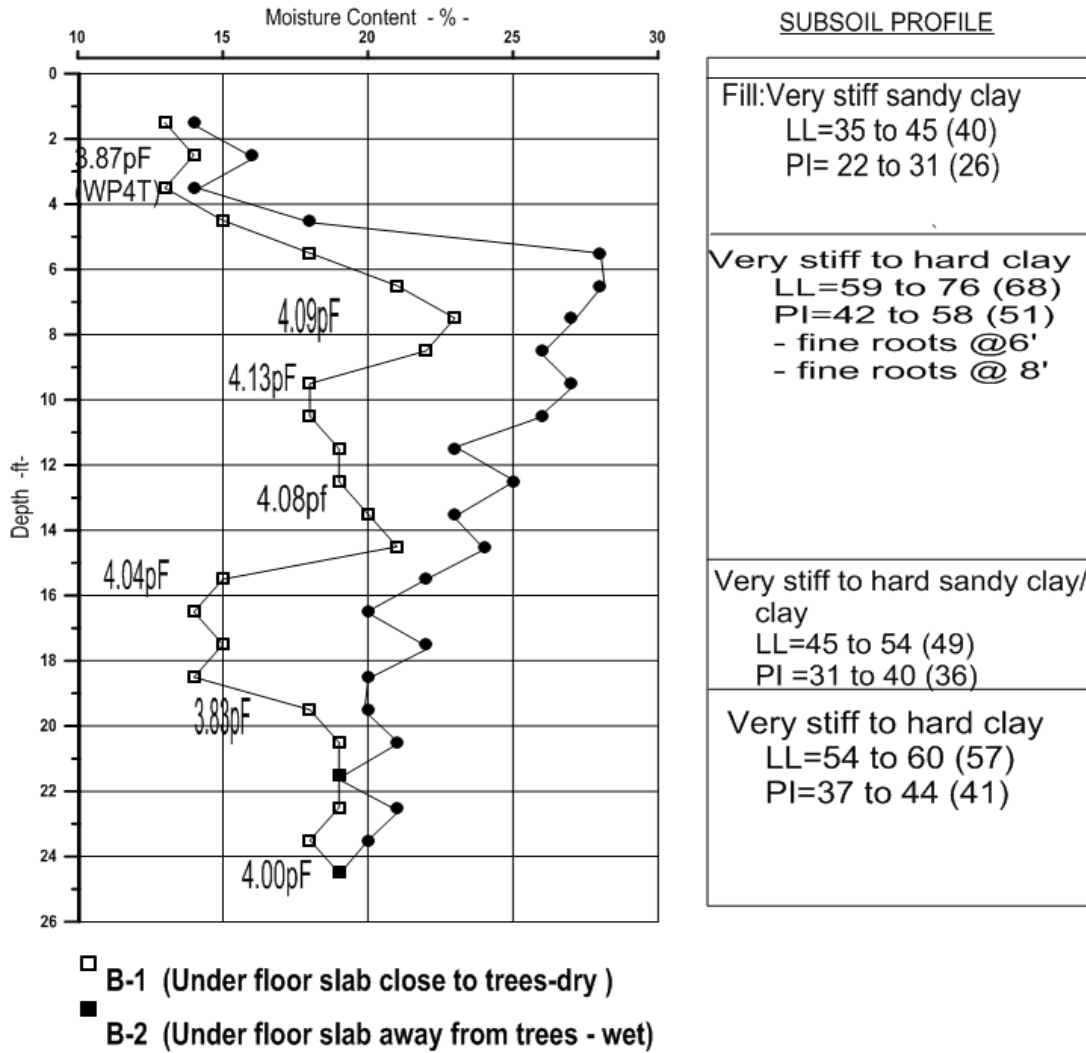
**Figure 4
Subsoil Moisture/Depth Profile
Case History 2**

A 2¾ inch thick layer of urethane foam was found under the floor slab at boring B-1. Free water was not encountered when drilling the borings. However, the pocket penetrometer value of 1.4 tsf at 9 feet in boring B-2 suggests that the water table which existed when the building was constructed was close to this level (unknown fact).

Feeder and fine roots were found at depths of 6 to 8 feet at boring B-1 under the floor slab about 12 feet from the exterior wall. The boring was beyond the drip line of the tree which was close to the perimeter wall. The lateral extent of root growth is unknown. However, there was a noticeable change of the elevation of the floor slab level about 38 feet south of the north wall, and 48 feet east of the west wall prior to injection of the urethane foam in 2012.

A comparison of the moisture content profiles at boring B-1 near the trees, and at boring B-2 in an area not close to trees, suggests that the depth of moisture loss due to the trees is about 25 feet below top of the slab. The same comments made for Case History 1 also apply to the 4.0pF soil suction found at 24 feet.

The 2014 elevation survey found that the elevation of floor slab at boring B-1 was about $\pm 1\frac{1}{2}$ inches below the initial construction level. Thus, total settlement of the ground surface at this location was about $4\frac{1}{2}$ inches considering that a $2\frac{3}{4}$ inch layer of urethane foam had been found below the floor slab.

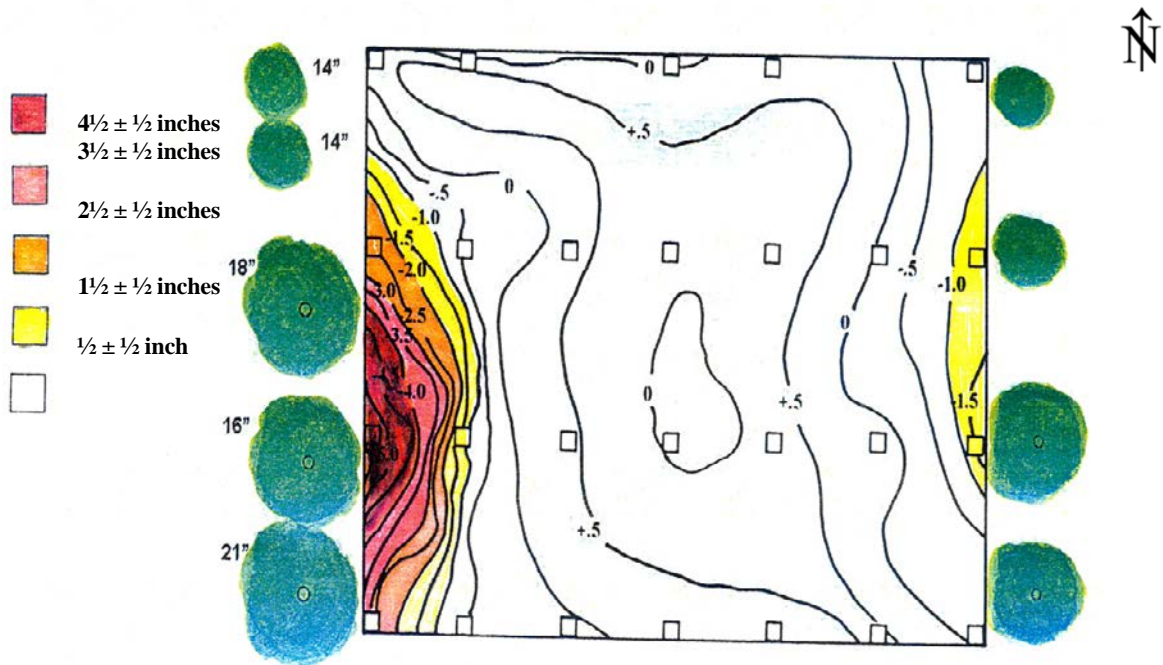
Figure 5
Contours of Elevation/Ground Floor

An elevation survey was performed in 2006, and the contours of relative floor slab movements are shown on Fig. 5. About $4\frac{1}{2} \pm \frac{1}{2}$ inches of settlement of the floor slab was found along the south wall, and $1 \pm \frac{1}{2}$ inches along the north wall. The elevation survey on the 3rd floor indicated that about 5 inches of settlement occurred at the underreamed pier just west of the southeast corner. The maximum differential settlement of the underreamed piers between adjacent exterior columns was about $2\frac{1}{2} \pm \frac{1}{2}$ inches.

The elevation survey indicates that the elevation of the floor slab at boring B-3 was ± 4 inches below what existed at the time of initial construction. This implies that total settlement of the original ground surface below the floor slab was $\pm 6\frac{1}{2}$ inches when considering that a $2\frac{1}{2}$ inch void was found below the settled slab.

Five oak trees ranging from 14 to 21 inches in diameter were planted along the south perimeter of the building. The canopies of the three trees at the southwest corner had to be pruned to keep branches from rubbing against the exterior walls and window glass. Also, 4 oak trees were planted on the north side of the building. I found that very little settlement occurred in areas not close to trees.

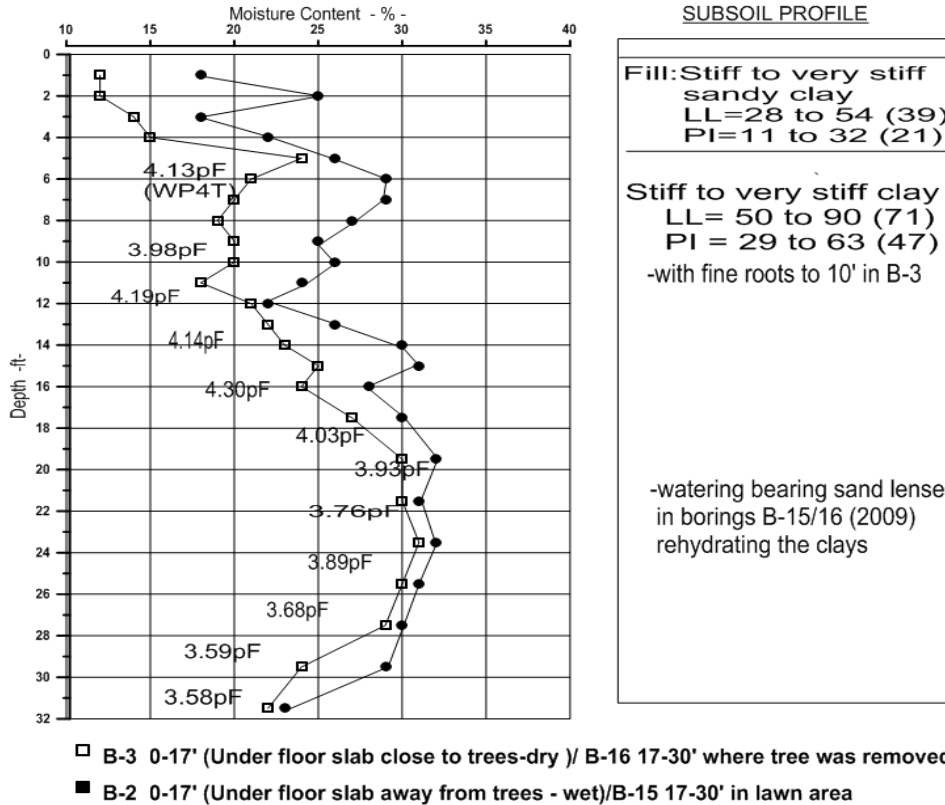
**Figure 6
Subsoil Moisture/Depth Profile
Case History 3**

Five hand auger borings were drilled to depths of 17 feet inside the building in 2006. The same procedures for field sampling and laboratory testing as discussed for Case History 1 were performed, and the subsoil data is shown on Fig 6.

Feeder and fine roots were found at depths of 6 to 10 feet in boring B-3 under the floor slab about 8 feet from the exterior wall. Feeder roots were found at a depth of 5 feet in boring B-2 about 40 feet north of the south wall where a 1/2 inch void was found below the floor slab. The boring was well beyond the drip line of the tree which is commonly, not correctly, assumed to be the extent of the root system. The lateral extent of root growth is unknown. However, there was a noticeable change of the elevation of the floor slab about 60 feet north of the south wall.

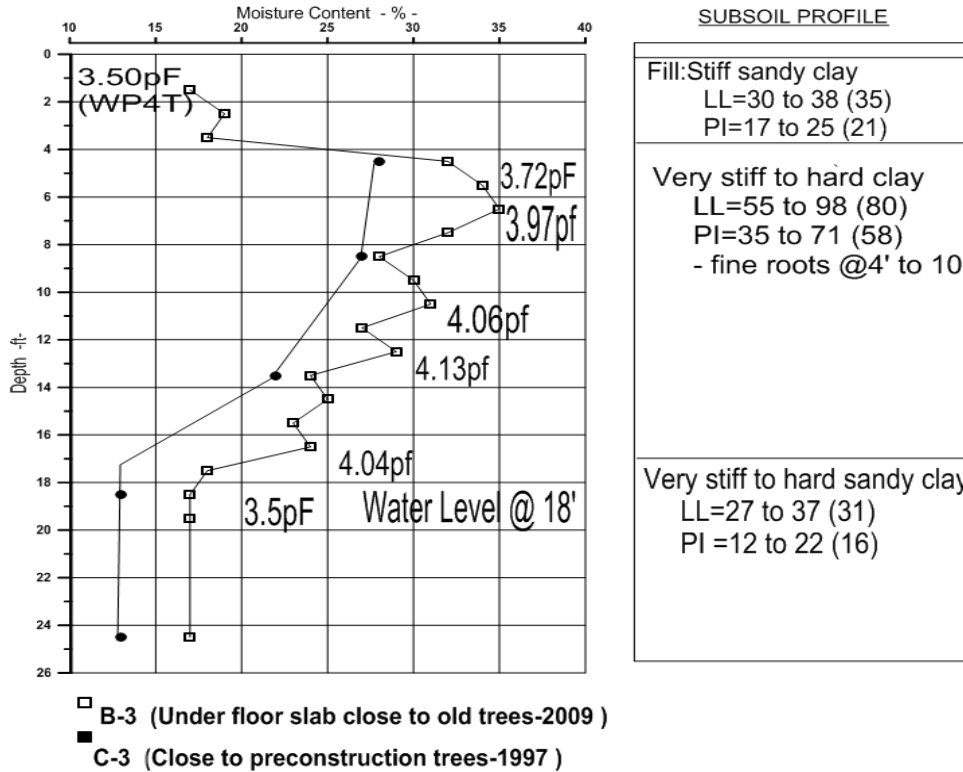
**Figure 8
Subsoil Moisture/Depth Profile
Case History 4**

The moisture profiles indicate that the moisture content increased about 5 percent in a 12 year period. However, the values of soil suction were about 4.0 pF from 6 feet below the slab to the top of the sandy clay layer at 17 feet. This boring had been drilled about 25 feet from the exterior perimeter, and all the heave had not occurred in 2009.

About 6 inches of heave was found in the southeast corner of Building 2 close to where three oak trees had been removed. This boring was located about 6 feet from the exterior wall, and the moisture contents were about 10 percent greater than at Building 1. Also, the value of soil suction was about 3.8 pF indicating moist clay. I believe that most of the heave, not all, had occurred at this location due to poor drainage around the building.
