Epoxy Rehabilitations and Protective Coatings of Lift Stations

J. B. Conant - Coatings Specialist

Featured Project - Lake Ridge Parkway Lift Station (Grand Prairie, TX)

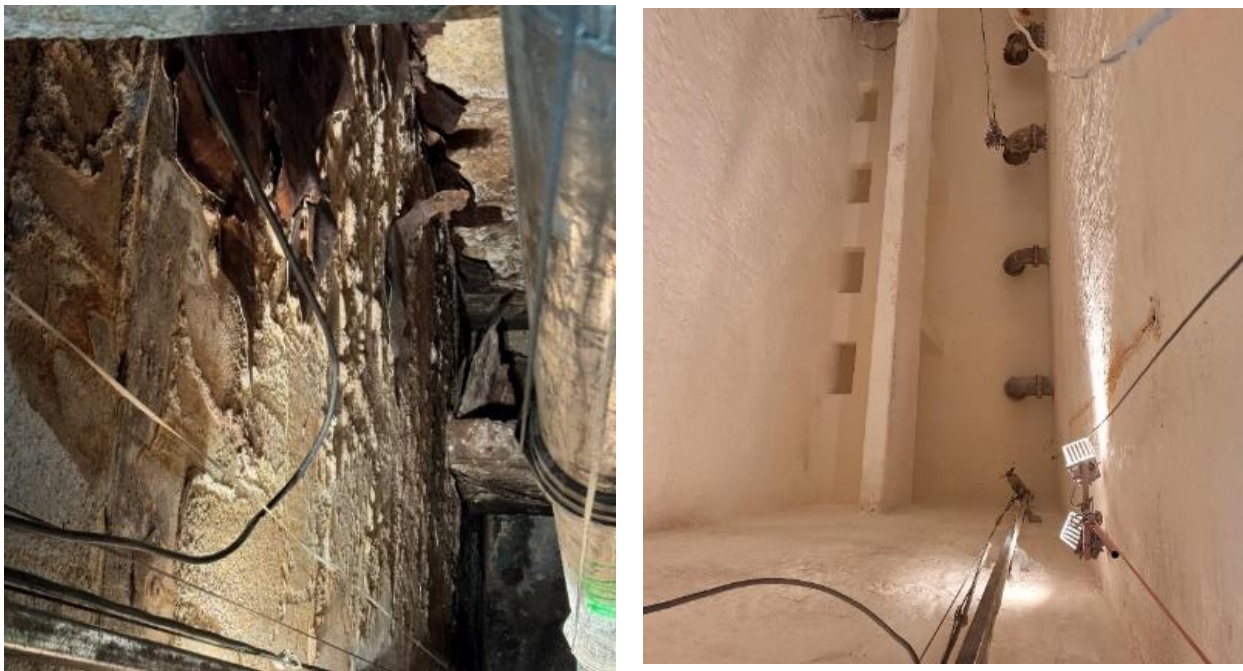
Figure 1. Featured Project – League City Highway 3 Lift Station & FM Rehabilitation (League City, TX)

Surface preparation: The pipes and pumps were removed and replaced with new equipment. The existing wet well was sandblasted top to bottom. Leaks around the incoming pipes were stopped using hydrophobic expanding grout. Thick 100% solids epoxy mastic was troweled into any holes or pipe gaps. The entire structure was then sprayed at 250 mils thickness.

Testing included Adhesion Results per ASTM D-7234, using portable pull-off adhesion test equipment. Adhesion pulls measured after the coating installed and cured. Roof (486 psi), East Wall (355 psi), West Wall (1,508 psi), Floor (664 psi).

The prime contractor did not have the new downstream manhole connected prior to the epoxy applicator arriving on the job. This created an issue with the job flow and required a return to the job for the additional coating work.

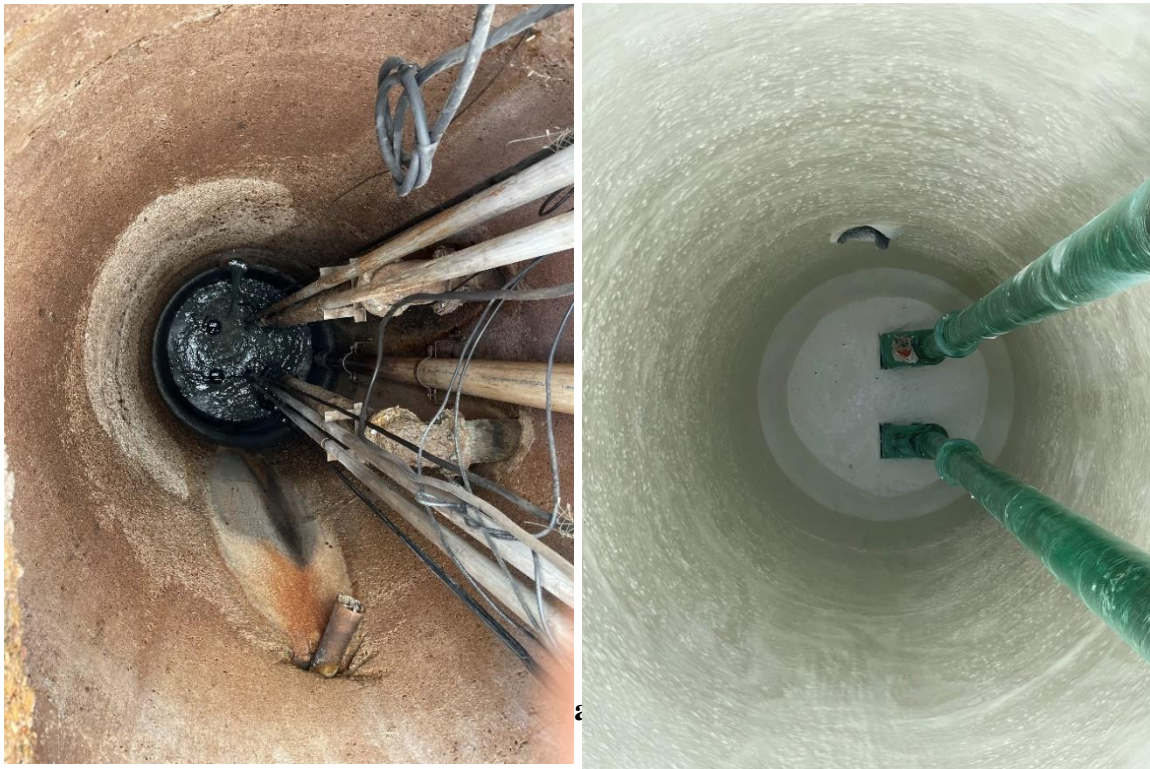
Figure 2. Featured Project – Lake Arlington Lift Station (City of Fort Worth, Texas)

Surface preparation: The structure's new concrete was abrasive blasted to achieve the desired surface profile for optimal adhesion. The specification required inspection activities by the manufacturer including the observation of surface preparation by a manufacturer's representative, the owner, and the owner's representative. After surface preparation, the contractor applicator lined the structure with 125 mils of high-performance epoxy.

An AMPP/NACE certified coating inspector witnessed testing conducted on-site. The post-application testing required spark testing and 30 total adhesion (pull) tests per ASTM 7234-21 (Standard Test Method for Pull-Off Adhesion Strength of Coatings on Concrete Using Portable Pull-Off Adhesion Testers) across the interior surface of the wet well. In most projects, pull test values that exceed 300 pounds per square inch (psi) are typically required. The average pull test value was greater than 550 psi, highlighting Warren epoxy's superior adhesion.

Rain during the project caused condensation to build up inside the enclosed and covered wet well. This caused some false readings during the spark testing. The environment had to be dried out using equipment to evaporate and dry the coating system.
