# Settlement of Foundations on Expansive Clays Due to Moisture Demand of Trees CIGMAT 2008

Kenneth E. Tand, P.E. Practicing Geotechnical Engineer

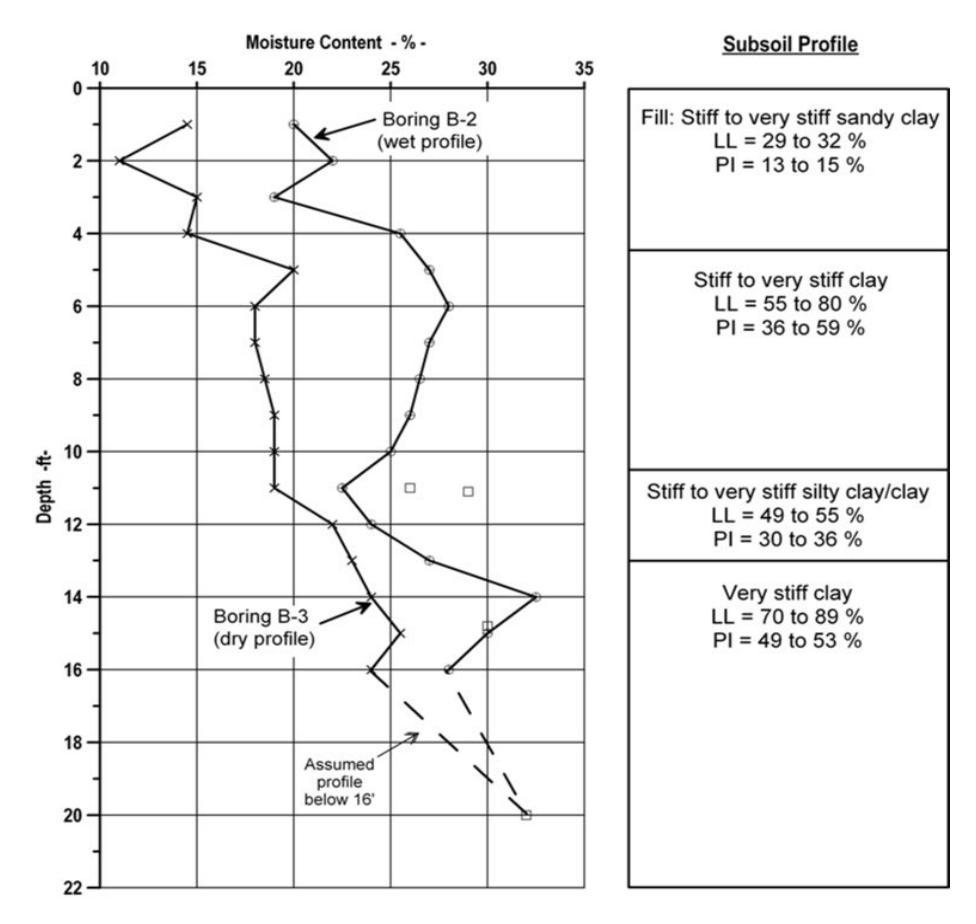
Figure 2: Moisture Profile with Depth (Site 1)

The floor slab is  $5 \pm 1$  inch thick, and it bears on  $3\frac{1}{2}$  feet of sandy clay fill. The fill is underlain by stiff to very stiff clay to a depth of 25 feet. The moisture profile along with a summary of the index tests is shown on Fig. 2.

The moisture profile with depth for boring B-3 near the area of maximum settlement is shown on Fig. 2. The moisture profile for boring B-2 located about 50 feet north of boring B-3 in an area not affected by the trees is also shown for comparison purposes. The  $\Box$ s shown in the figure were moisture data taken from the original geotechnical report performed by others. Note that the depth of moisture variation is below the depth of 15 feet, and it may be 20 feet or deeper.

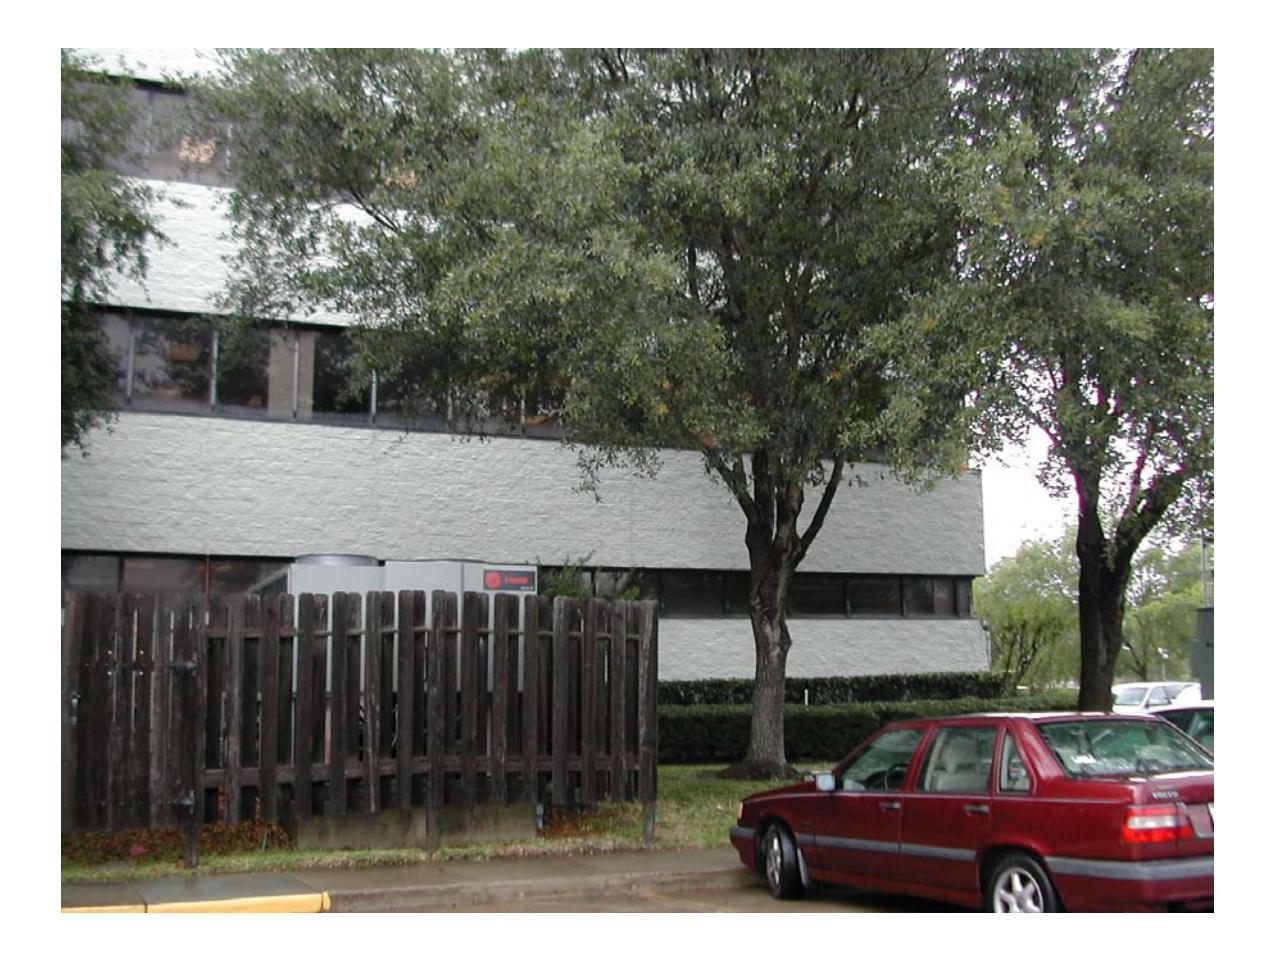
# Photo 1: Oak Trees Causing Settlement

Two 16 to 18 inch diameter oak trees had been planted 16 feet from the edge of the building in a small landscape area at this location (see photo 1). The drip line of the trees had reached the perimeter of the building, and the branches had to be pruned back to keep them from rubbing against the building.

A more economical approach would be to locate the trees far enough away from the building so that moisture demand of the trees on the clay subsoils does not cause settlement of the foundation. The zone of moisture influence was about 40 feet beyond the drip line at Site 1. However, this occurred because the floor slab restricted recharge of moisture. The lateral zone of influence would probably be much less if the tree was situated in a large landscape area to allow rainfall and irrigation water to recharge the clays. A deep impermeable root barrier at the perimeter of the building can be installed to minimize the potential for growth of roots below the floor slab.

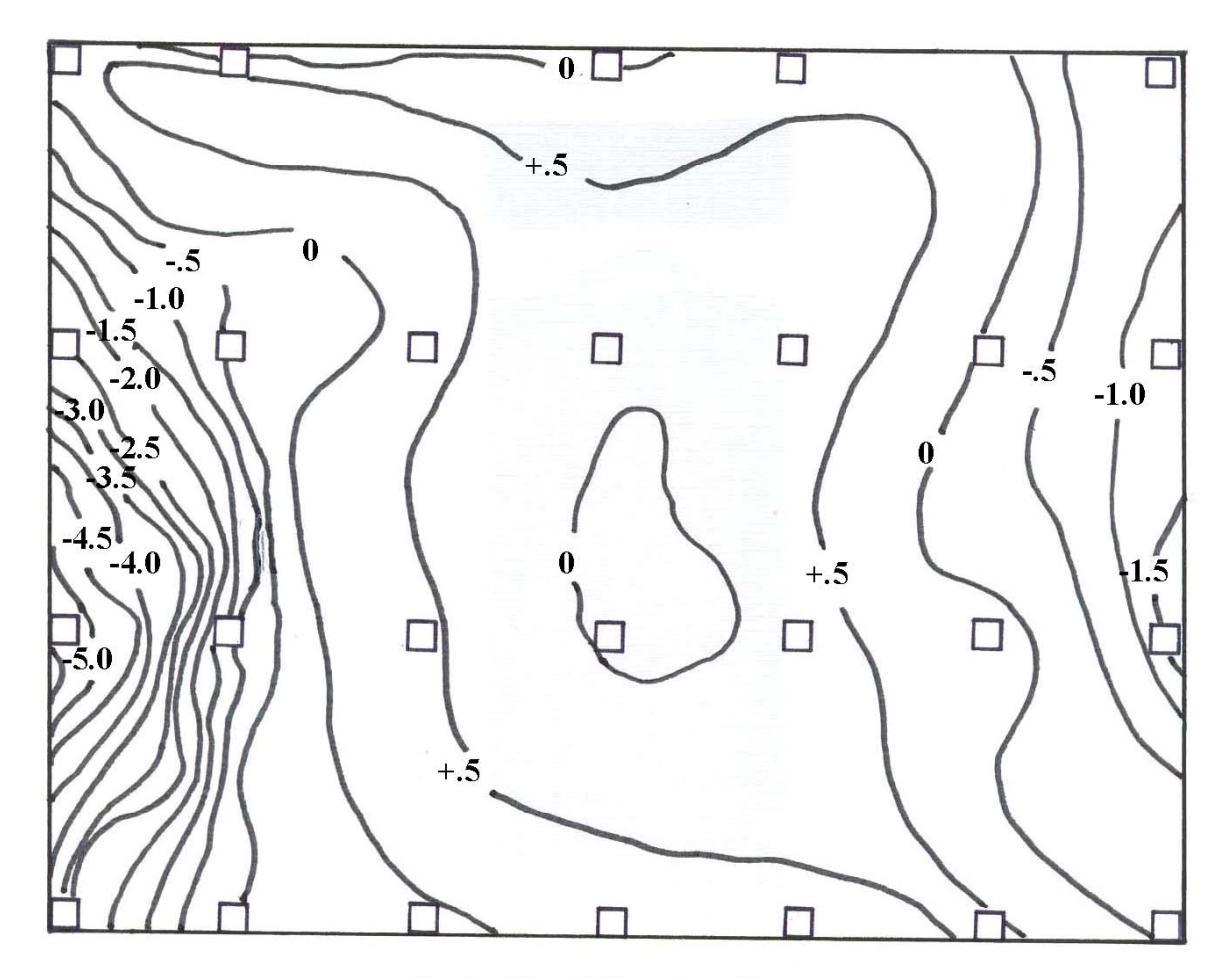
Fig. 3: Site 1 Elevation Contours

An elevation contour profile of the ground supported slab is shown on Fig. 3. It clearly shows that 5 inches of settlement of the floor slab occurred along the south wall just west of the SE corner. This settlement reflected up into the elevated floors indicating that the

footings also settled 5 inches. The soil boring drilled in this area revealed the presence of a  $2\frac{1}{4}$  inch void below the slab. Thus, total settlement of the ground surface below the slab was  $7\frac{1}{4}$  inches (5 +  $2\frac{1}{4}$  =  $7\frac{1}{4}$  inches). The contour profile indicates that the zone of settlement extends about 40 feet beyond the drip line of the trees located at the edge of the building.

About  $1\frac{1}{2}$  inches of settlement of the floor slab occurred along the north wall west of the NE corner. The soil boring drilled in this area revealed the presence of a  $1\frac{1}{2}$  inch void below the slab. Thus, total settlement of the ground surface below the slab was 3 inches ( $1\frac{1}{2}$  +  $1\frac{1}{2}$  = 3 inches).

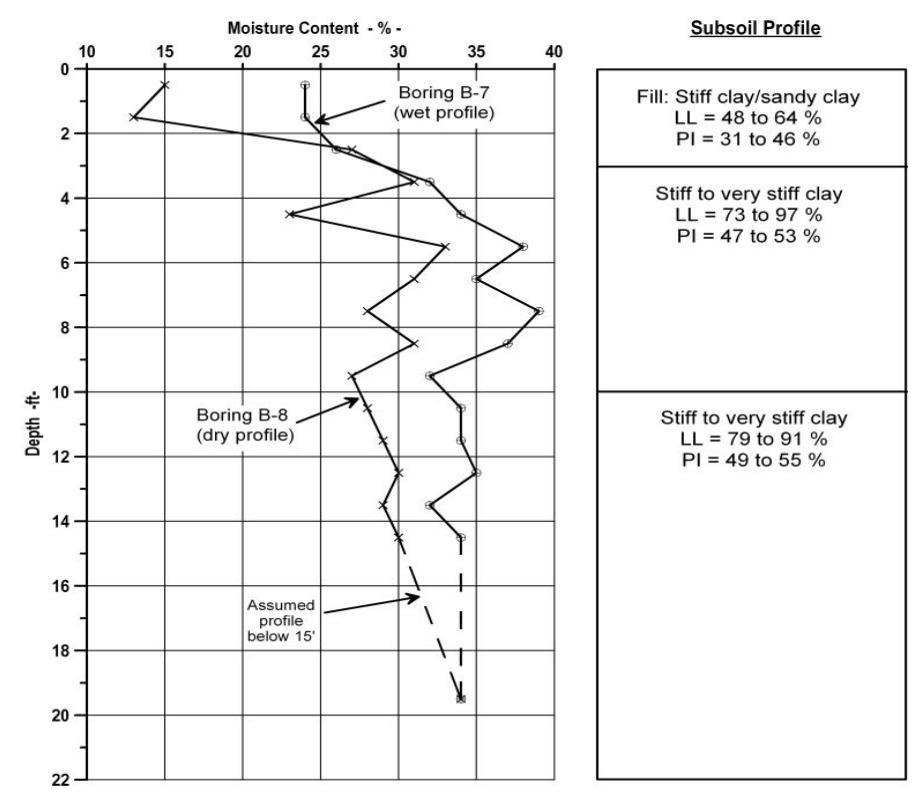
Figure 4: Moisture Profile with Depth (Site 2)

The maximum settlement occurred along the south wall of building C near the SW corner. The floor slab in this area was about 5<sup>1</sup>/<sub>4</sub> inches thick, and it was bearing on 2 feet of clay fill. The fill was underlain by clay to a depth of 55 feet. The moisture profile along with a summary of the index properties is shown on Fig. 4.

The moisture profile with depth for boring B-8 near the area where maximum shrinkage occurred is shown on Fig. 4. The moisture profile for boring B-7 located about 125 feet northeast of this location in an area not affected by the trees is also shown for comparison purposes. Note that the depth of moisture variation is below the depth of 15 feet, and it may be 20 feet or deeper.

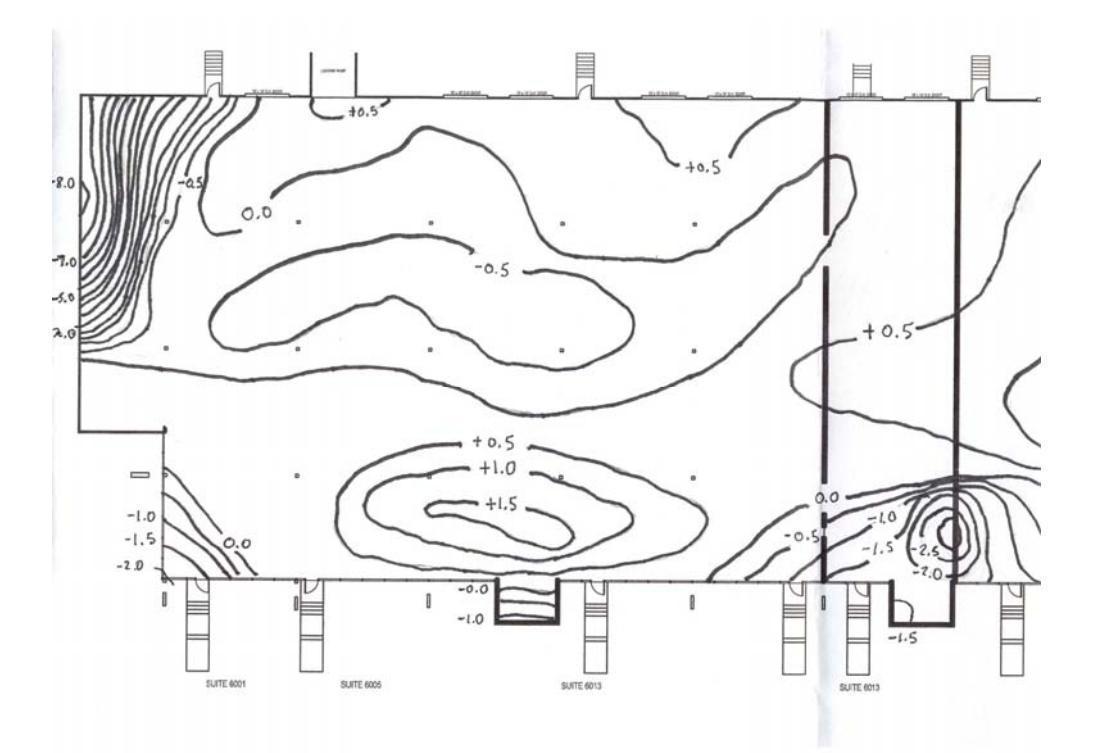
Fig. 5: Site 2 Elevation Contours

The elevation survey of the south half of the building is shown on Fig. 5. It clearly shows that about 8 inches of settlement of the ground supported floor slab occurred in this area. A void was not found below the floor slab at this location. Settlement had sheared off the rebar connecting the tilt panels to the floor slab in this area, and angle irons had been quick bolted to tie these two elements together. The contour profile indicated that the zone of settlement is about 25 feet beyond the drip line of the tree. There were openings at the top of the tilt panels indicating that settlement of the footings had occurred.

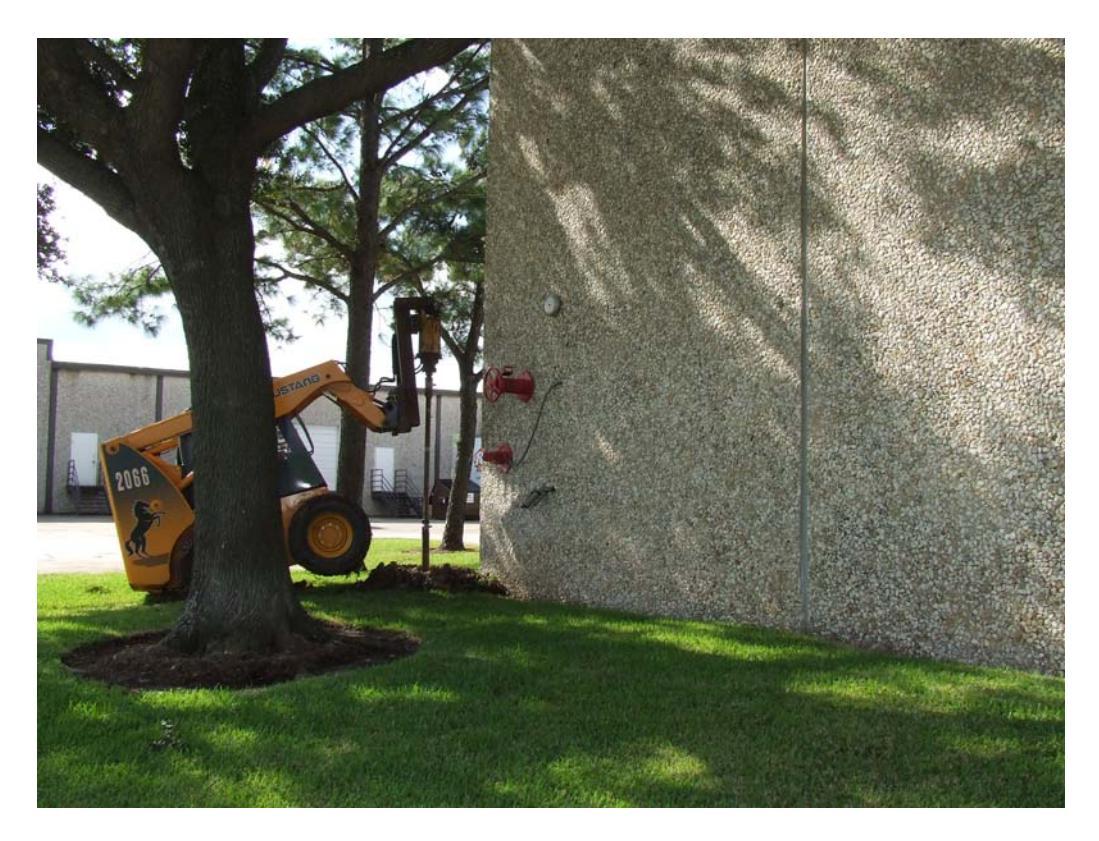
Photo 2: Oak Tree Causing Settlement

As shown in Photo 2, a 22 inch diameter oak tree had been planted close to this area. Also, two 10 to 14 inch diameter trees had been planted west of the SW corner of the building.

The floor slab was not level throughout this building. There were areas where  $\pm 1\frac{1}{2}$  inches of heave occurred, as well as settlement at other locations near trees. It is readily apparent that moisture demand from the oak tree caused deep seated shrinkage of the clays resulting in settlement of the footings and floor slab.
