WATER PIPELINE FAILURES IN THE ACTIVE ZONE

C. Vipulanandan¹, W. Qiao² and H. Hovsepian³

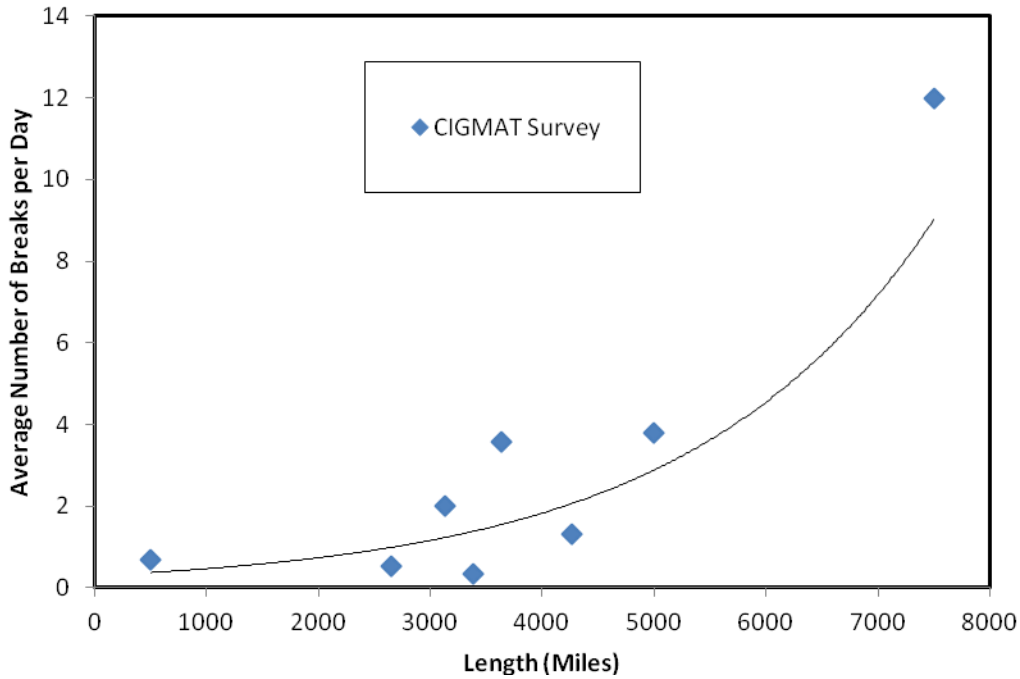
Figure 1. Correlation between Pipe Length and Average No. of Breaks per Day

It has been reported in the literature that length is a factor to the breaks (Rajani 2001). Total length of pipelines in the system for each city is shown in Figure 8, and the pipe length varied from 500 to 7500 miles. The variation of daily breaks with pipe length for various cities is shown in Figure 9. The nonlinear relationship (Model 4) was as follows:

$$PB = 0.295e^{0.0005L} \quad (L \leq 7500 \text{ miles}) \quad (1)$$

where PB= Average No. of Breaks per Day

L = Total Length of Pipelines in Each City (mi) (≤ 7500 miles)

The coefficient of correlation (R) was 0.77, which was the highest among the parameters investigated. The total length of pipelines included in this study was over 28,000 miles.

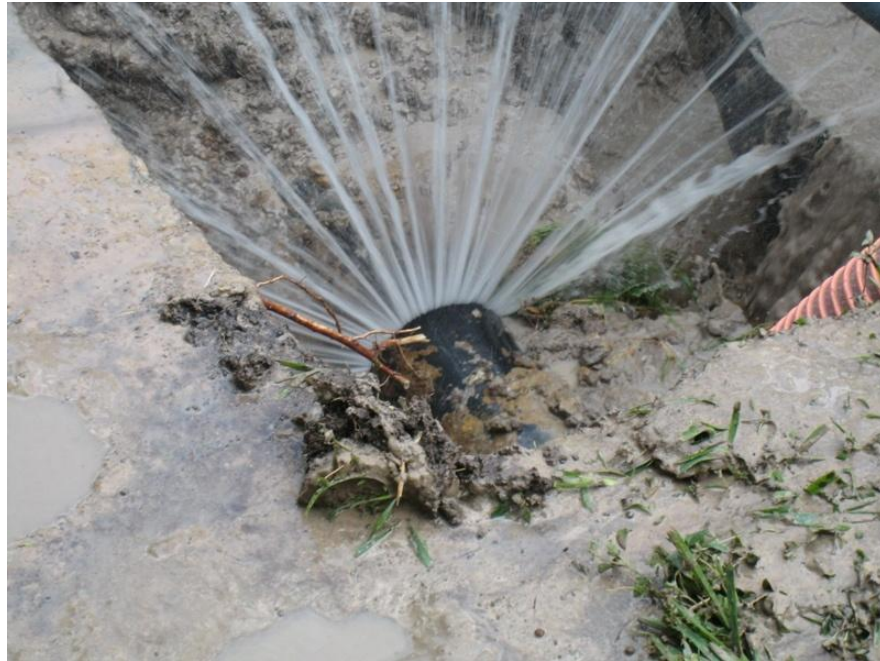
Figure 2. Circumferential Crack for 8” CI Pipe

Case 2: Circumferential Cracking in CI Pipe

About 37% of the failures were observed in the CI pipes. Typical CI pipe failure is shown in Fig. 2, where a 8 in diameter CI pipe has failed by circumferential cracking (Type 2 failure). The pipe was located at a depth of 4 ft below the ground in clayey soils in the active zone.

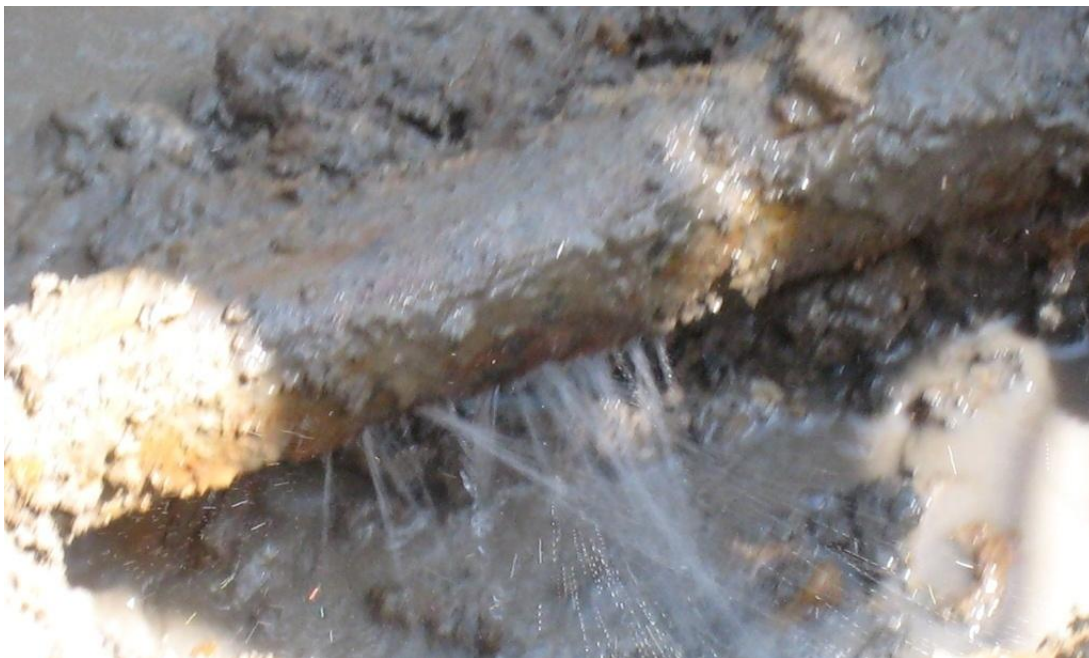
Figure 3. Longitudinal Crack 2” CI Pipe (325 W. 27th Street)

Case 3: Longitudinal Cracking in CI Pipe

About 37% of the failures were observed in the CI pipes. Another type of CI pipe failure is shown in Fig. 3, where a 2 in diameter CI pipe has failed by longitudinal cracking (Type 2 failure). The pipe was over 40 years old. The pipe was located at a depth of 1 ft below the ground in CL clayey soils in the active zone. The longitudinal cracking might be due to the internal water pressure, active zone changes in temperature and age.
