PREDICTING THE REMAINING SERVICE LIFE OF WATER SYSTEM PIPES

Aldo Ranzani

Renew Austin Program Supervisor
City of Austin Water Department
625 E 10th Street, Suite 400
Austin, Texas 78701-2612

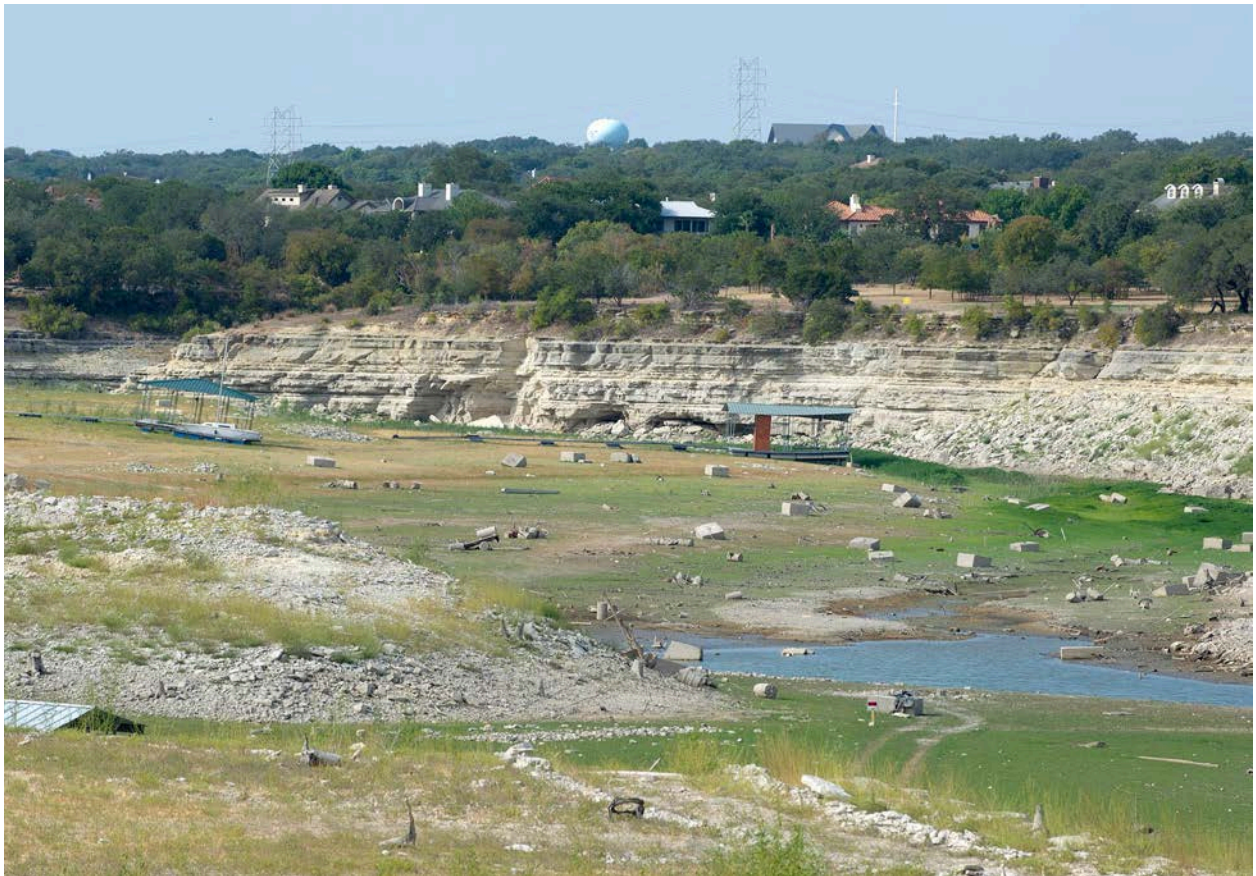
Lake Travis

Lakes Travis and Buchanan, the region's major reservoirs, now hold about 762,000 acre-feet, or 38 percent of capacity.

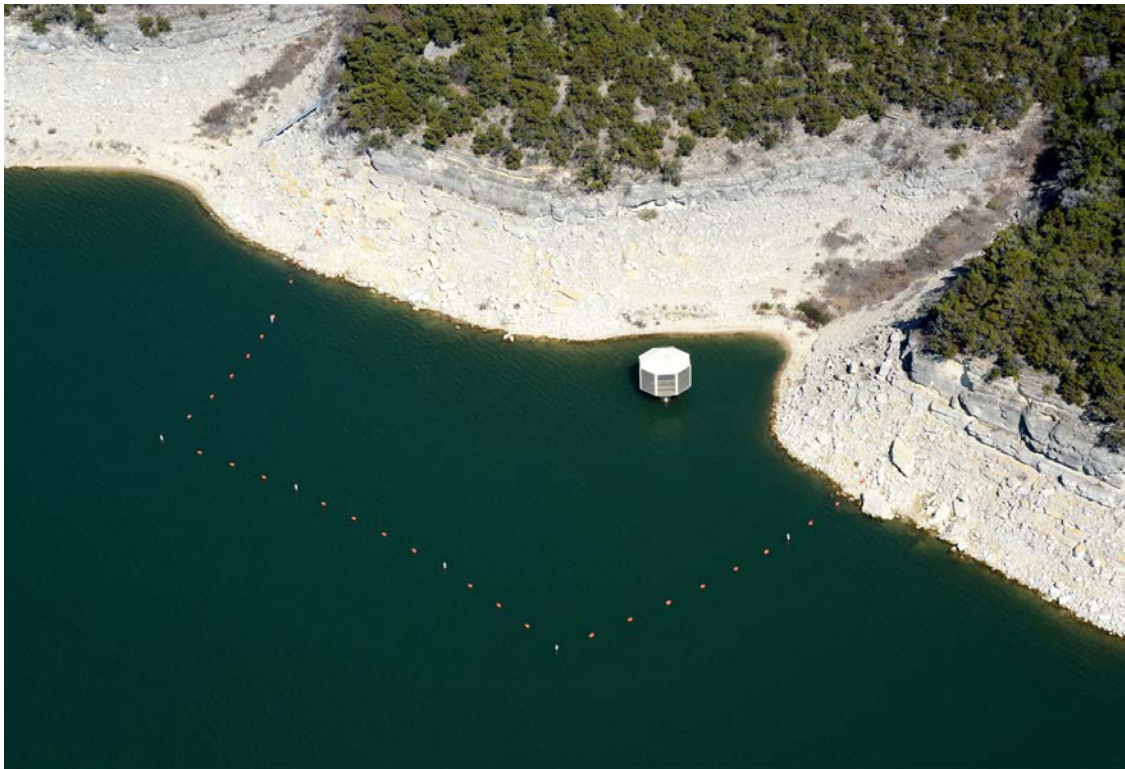
Image # 140212 6211
Date 02.12.14

Water Treatment Plant # 4 under construction

The \$524 million Water Treatment Plant No. 4 (WTP4) will treat 50 million gallons of water per day that will serve the north and northwest pressure zones of Austin. The design of the plant allows for future expansion to 300 million gallons of water per day. The first phase of the project, which started in November 2010, has a three-level lake intake pump, which will occupy 4.5 acres in Lake Travis.
