# Settlement of Foundations on Expansive Clays Due to Moisture Demand of Trees CIGMAT 2008

Kenneth E. Tand, P.E. Practicing Geotechnical Engineer

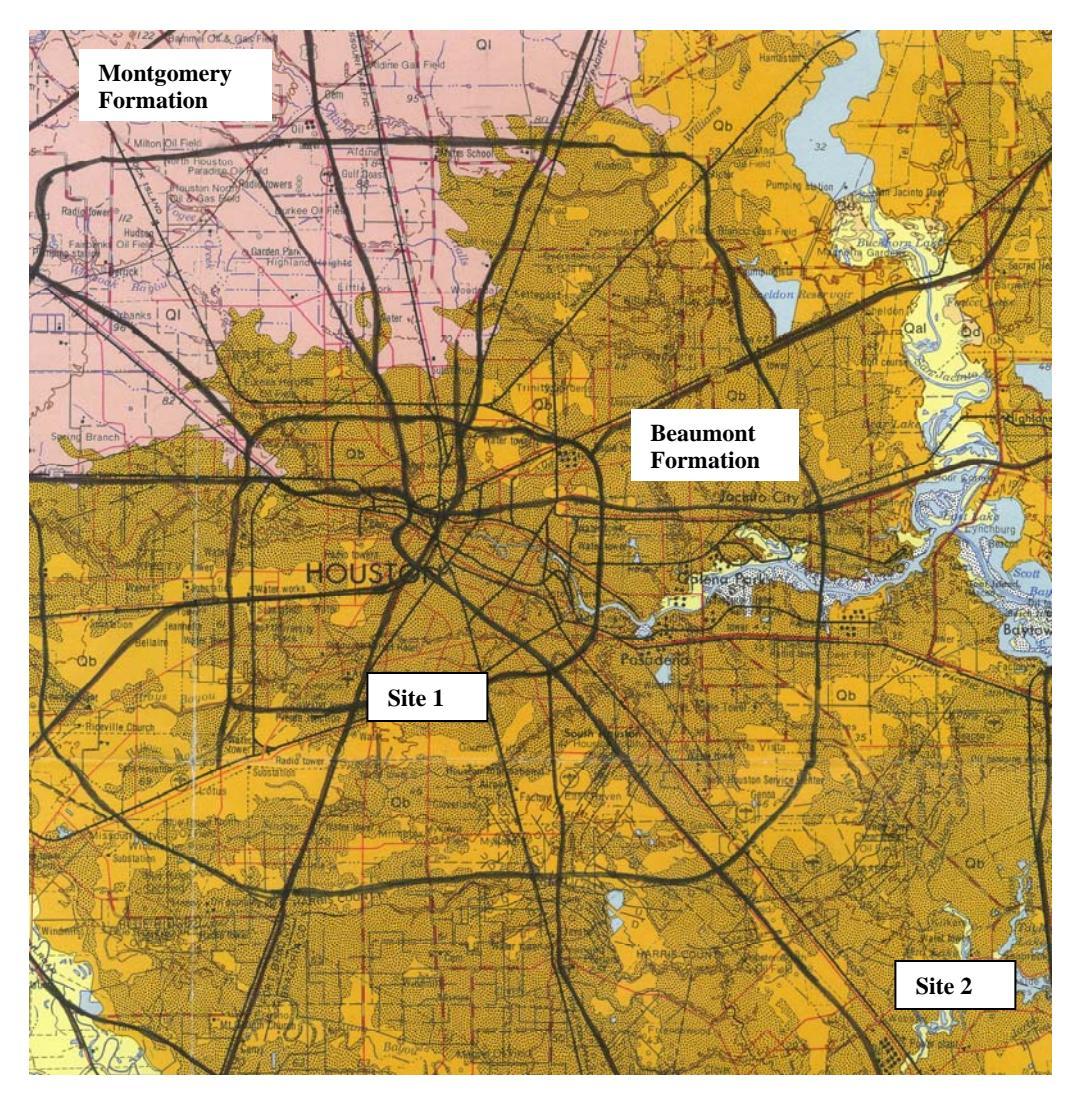
Fig. 1: Houston Geological Formations

The greater part of Houston is situated on a geologic formation known as the Beaumont Clay (see Fig. 1). However, the Montgomery formation is located in the northern and western areas of Houston. Both geologic formations were deposited in Pleistocene times in shallow coastal river channels and flood plains. The courses of river channels changed frequently during the period of deposition generating a complex stratification of sand, silt, and clay.
