## **PIPE BREAK ANALYSIS – WATER**

Aldo Ranzani,

Public Works and Engineering Department City of Austin, Austin, Texas

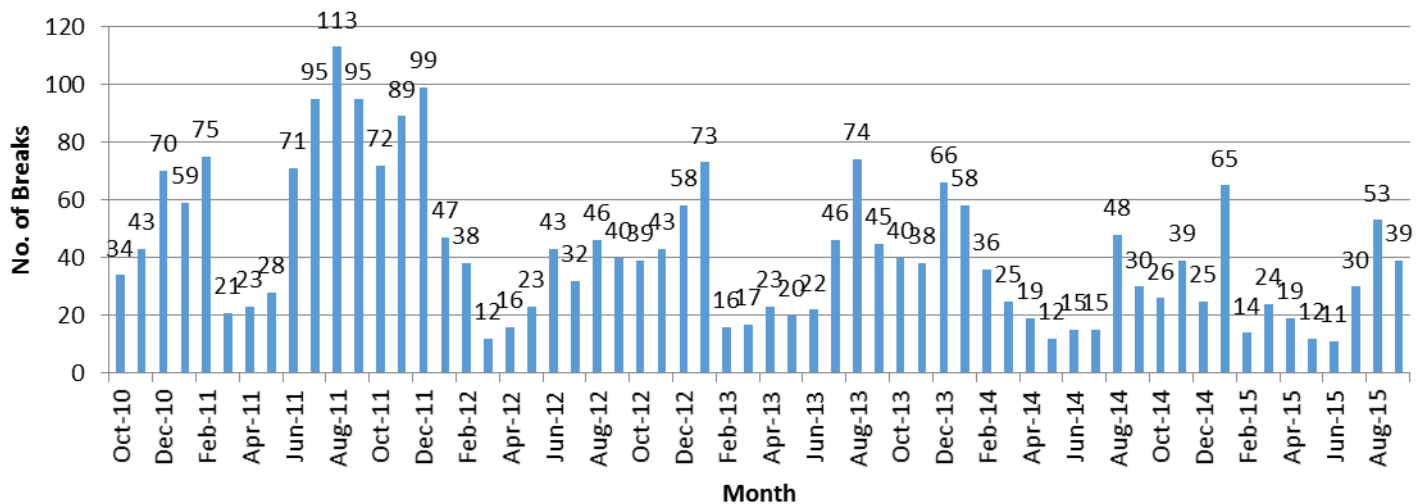
## Water Main Leaks

An initial breakdown of the data revealed that repeat pipe breaks rose sharply in August and again, almost as sharply, in December. A contributing factor to the tendency to break pipe in the months with higher temperatures might be seasonal increases in water usage. During such months when the temperature rises and the precipitation decreases or ceases entirely, water usage and pumpage increases. Besides the soil condition, pipe breaks appear to rise similarly to the pumpage increases, which might suggest that the added water being sent through the already stressed pipes may stress them further
