Epoxy Rehabilitations and Protective Coatings of Lift Stations

J. B. Conant - Coatings Specialist

Featured Project - Lake Ridge Parkway Lift Station (Grand Prairie, TX)

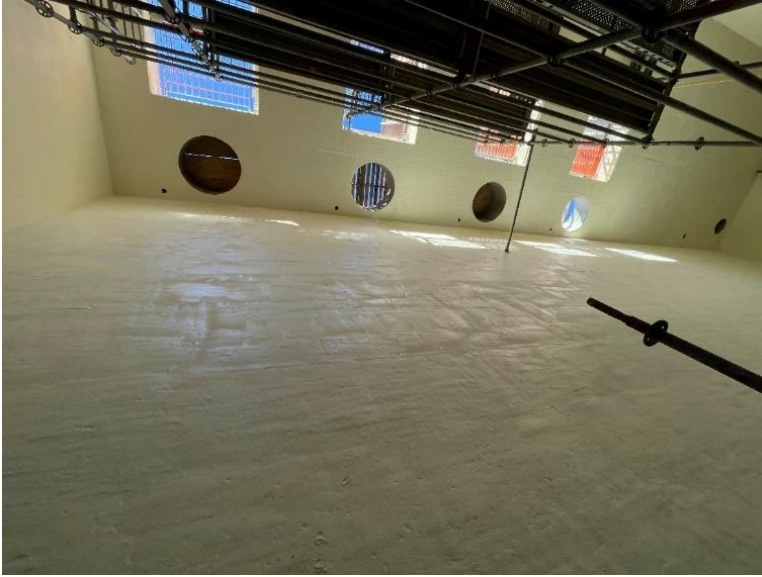
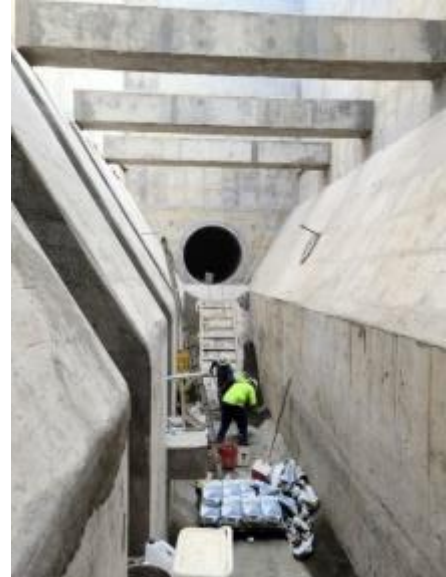
Rain during the project caused condensation to build up inside the enclosed and covered wet well. This caused some false readings during the spark testing. The environment had to be dried out using equipment to evaporate and dry the coating system.
