## **Testing Protocol for Manhole Coatings**

**Abstract:** Since coatings are being applied to leaking manholes, it is critical to evaluate the coating performance near field conditions. Hence a test protocol has been developed to test the coating under varying hydrostatic pressure to determine effectiveness of coatings to control leak with minimal deformation and/or blisters. Also the tensile bonding of the coating to the substrate will be quantified.

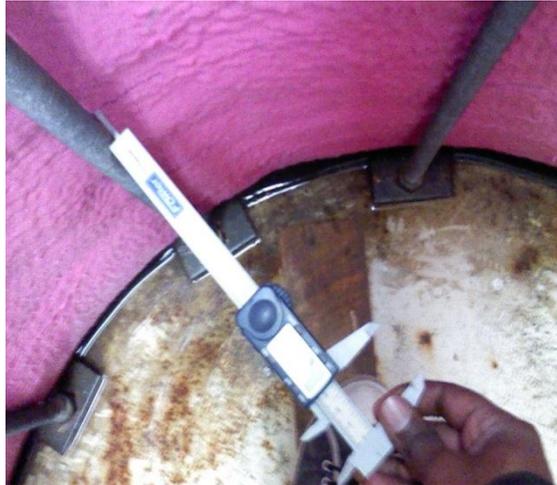
- (iii) After applying the coating, the manhole is placed in a full scale test chamber. Hydrostatic pressure will be applied by filling the annular space between the outside chamber and manhole.
- (iv) Initial readings of coating with respect to the steel rods will be taken using a vernier caliper (accuracy of noted 0.001”).
- (v) As specified, the hydrostatic pressure will be gradually increased and the deformation of the coating will be closely observed by measuring the spacing between the steel rod and coating (Figure 1).
- (vi) Leaking of water through the coatings will be quantified.

**Figure 1: Vernier caliper used for deformation measurement**
